Allen McColloch Pipeline - Inspection Update Action Plan

January 8, 2024

Allen McColloch Pipeline (AMP) Inspection Update Action Plan

Summarize condition assessment of AMP Prestressed Concrete Cylinder Pipeline (PCCP) by including results of recent inspection & preliminary risk analysis. Review mitigation measures & present pipeline rehabilitation plan.

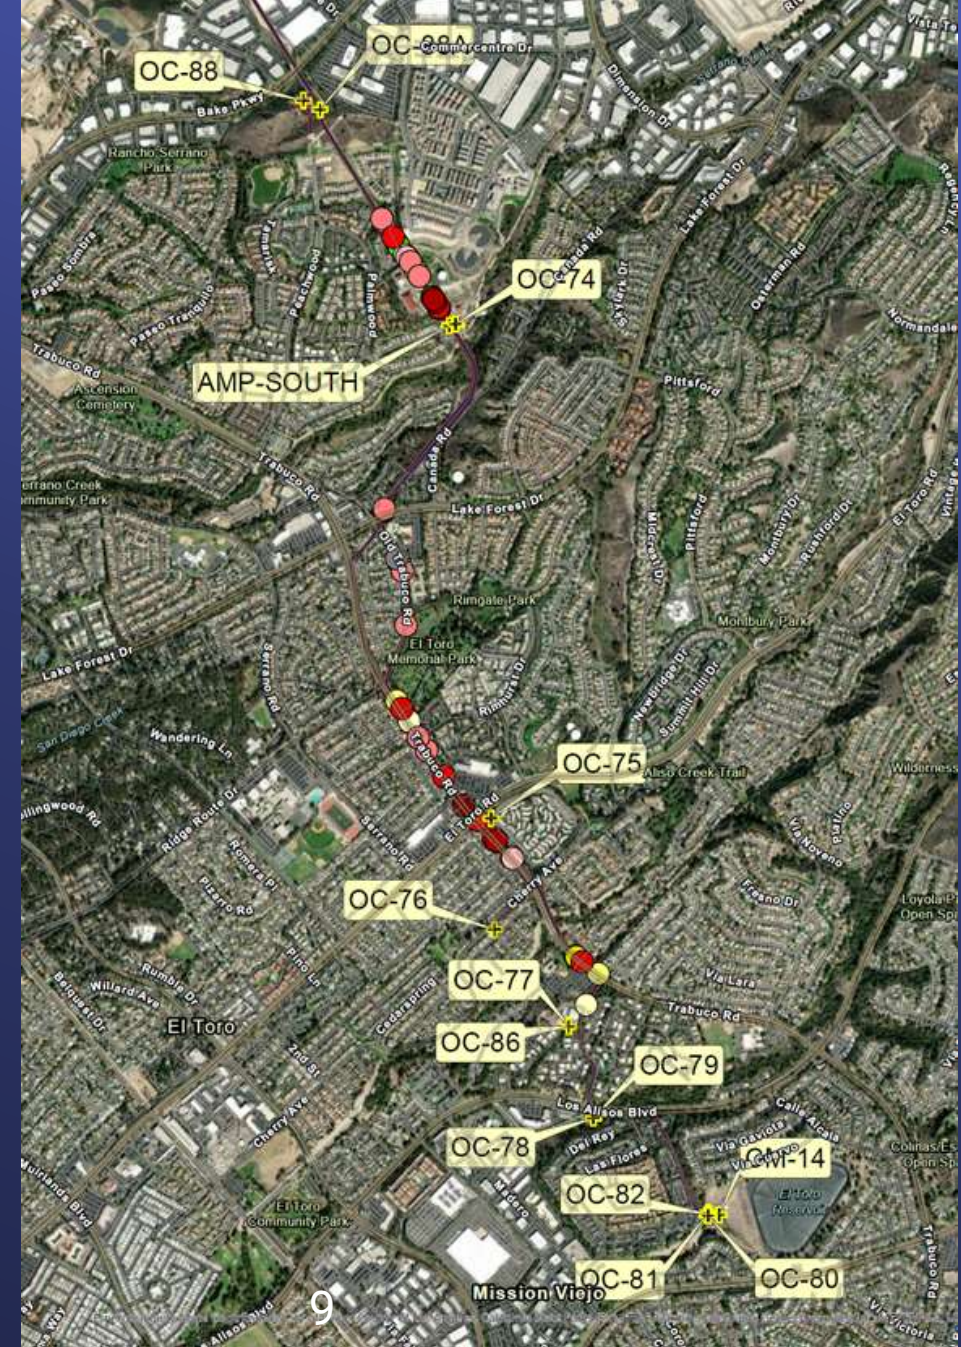
- Electromagnetic inspection in Nov 2023
- Inspection report completed in Dec 2023
 - Anomalies consistent w/prestressed wire damage
 - 81 wire break locations (5 to 130 per segment)
 - 73 new segments compared to 2018 inspection
- Inspection summary: 44 critical pipe segments

Wire Breaks (WB)	No. of pipe segments
130	1
95-70	4
60-50	8
45-40	12
35-30	5
25-20	14
15-5	37
Total	81
