THE METROPOLITAN WATER DISTRICT  
OF SOUTHERN CALIFORNIA

# Board Report

### • Operations Monthly Activities for September 2024

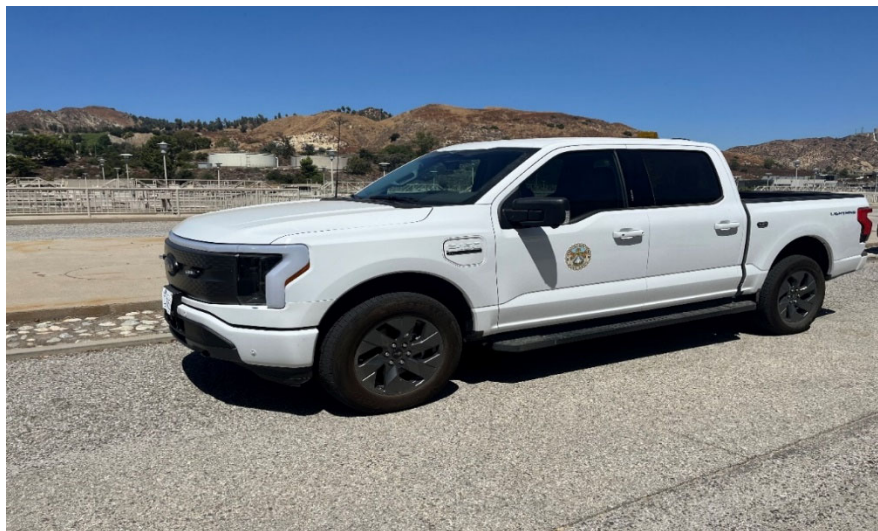
In preparation for rollout of Metropolitan's zero-emission vehicles (ZEV), several teams have been piloting ZEVs to determine best use of the technology and gain feedback. For the past three months, the Jensen Treatment team has utilized a Ford Lightning to complete operations at the treatment plant. This use case demonstrates the application of new technology and its practical functionality. This zero-emission truck has received positive feedback from staff and charging has been effective to maintain continuous utilization by staff in their operation of the treatment plant.

**Integrating a zero-emission truck for Jensen plant operations**

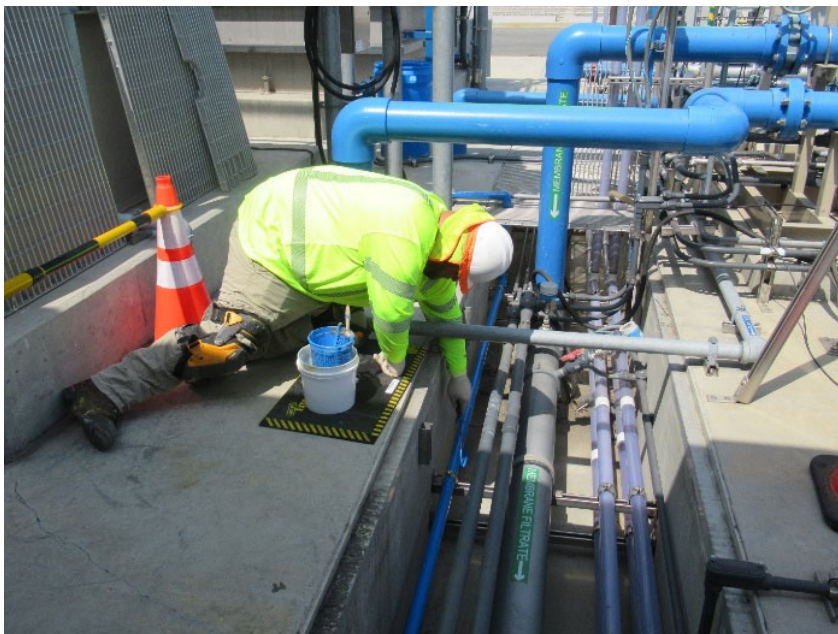
Staff coated piping at the Grace F. Napolitano Pure Water Southern California Innovation Center in Carson. The coatings applied enhance reliability of the piping system and help with identification of the pipe contents to provide safety awareness for staff working at the facility.

Staff coating pipes at Napolitano Center

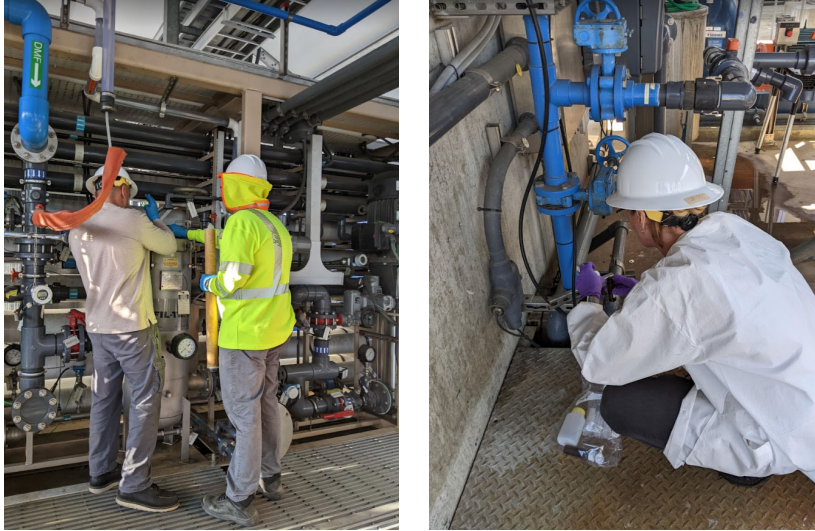
Staff continued to perform VOC spike testing using acetone to demonstrate removal in gas and liquid forms and confirm operational setpoints to support full-scale permitting and future direct potable reuse testing. Metropolitan staff supported Los Angeles County Sanitation Districts emissions testing to support future environmental permitting of the full-scale system.

**Staff replacing cartridge filters ahead of reverse osmosis system (left) and collecting samples during VOC spike testing (right)**

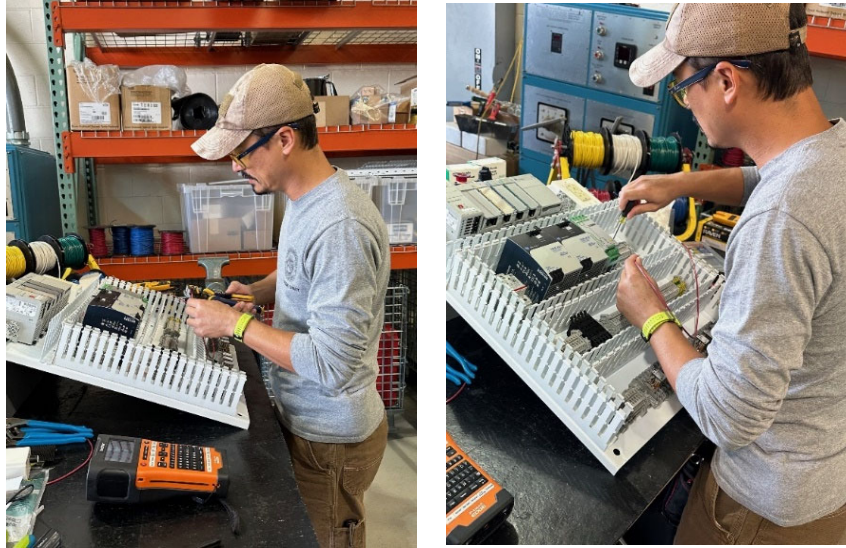
At the Diemer plant, staff wired the control panel for a sodium hypochlorite feed pump as part of a chemical injection system that will be used at the OC-88 pump station to control nitrification. Nitrification is a process of biological conversion of ammonia to nitrite within chloraminated water systems, potentially causing a decrease in chloramine residual. Under more serious nitrification events, there can be a notable decrease in chloramine residual that allows bacterial growth. This chemical feed system was designed to inject sodium hypochlorite directly into the Allen-McColloch Pipeline at OC-88 to help maintain a target chloramine residual and minimize nitrification.

**Staff is working on a nitrification control chemical feed system**

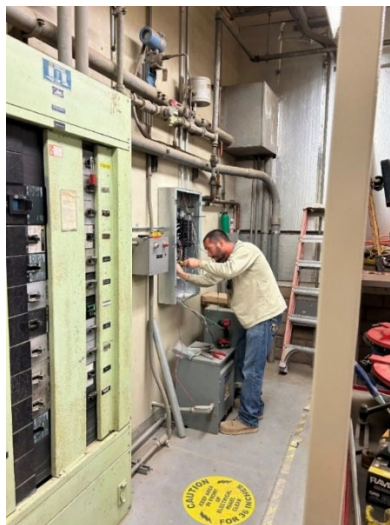
Staff continued upgrading the 240V electrical distribution panels at the Skinner Administration Building and a Service Building which houses the Skinner Fleet, Mechanical, and Electrical Teams. The existing panels are original equipment from the 1970s which are obsolete and beyond their useful life. The replacements will ensure safe and reliable electrical distribution for critical control room and maintenance shop operations.

**Staff replacing electrical distribution panel in the Mechanical, Electrical, and Fleet shop at the Skinner plant**

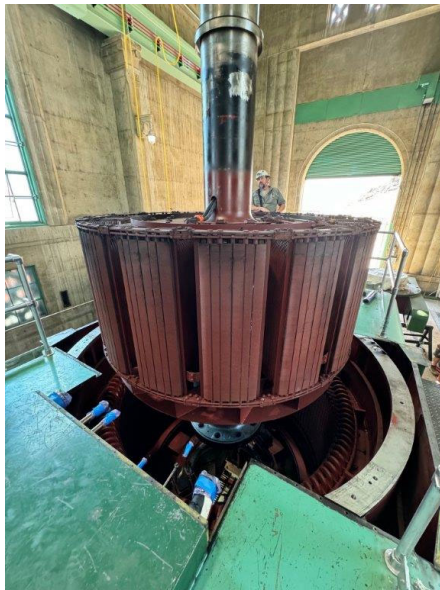
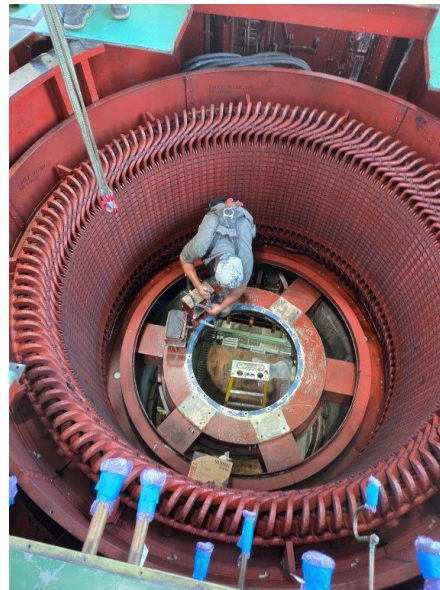
Pump maintenance team and pump plant staff worked together at the Eagle Mountain pump plant to disassemble the Unit 9 pump. The pump was removed from service and will undergo maintenance to repair or replace worn components. Pump plant staff removed a lubrication oil pump for repair. The lubrication system ensures the 12,500hp motor and pump bearings are lubricated during operation. Proactively maintaining the auxiliary systems mitigates the risk of costly repairs to the CRA main pump units. Data collected throughout this maintenance will be analyzed by Engineering to help determine the scope of the CRA Main Pump Rehabilitation capital project.

Removing the rotor and hydraulic jacks from Eagle Mountain Unit 9 stator

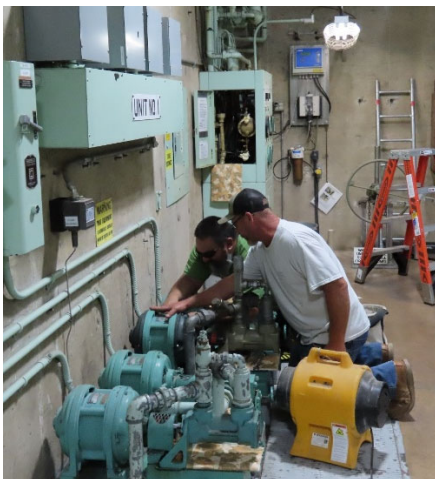
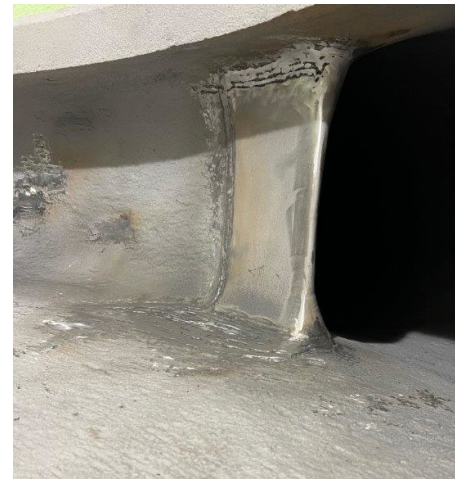
Removing a lubrication pump and motor for rebuild (left), splitter welding to build up worn areas (middle), and splitter weld repairs completed and ready for coating repairs (right)

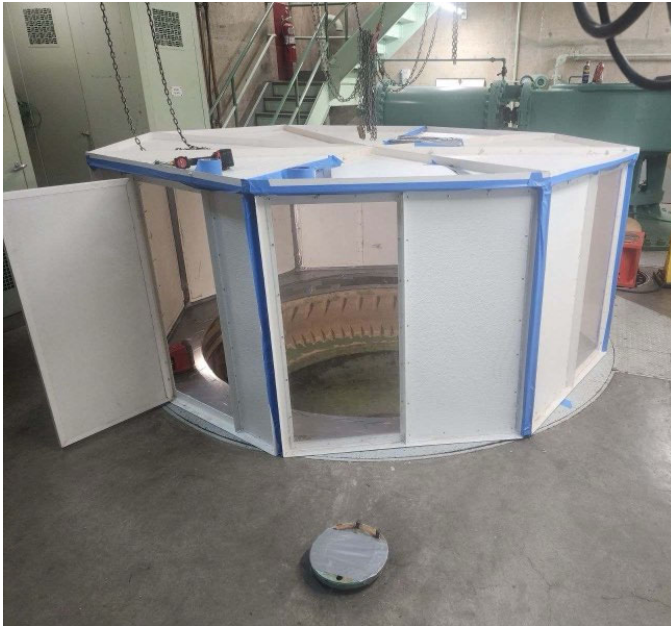
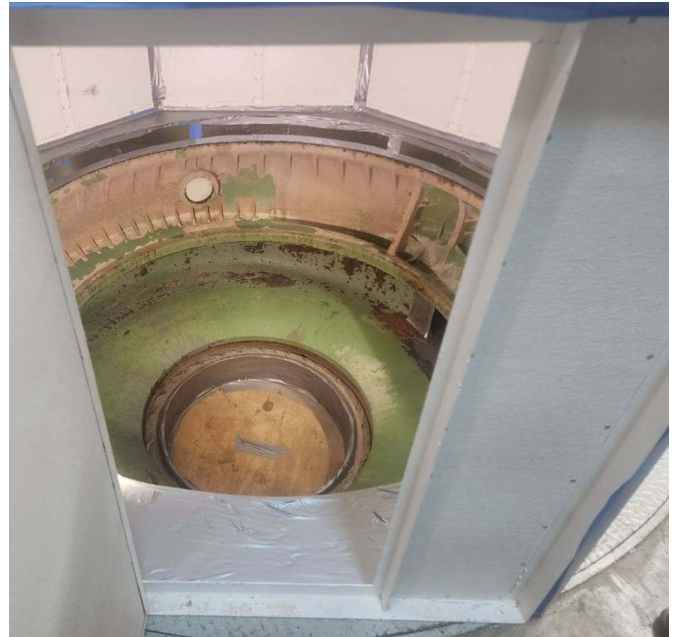
The desert coaters installed temporary containment specifically designed for blasting pump bowls. For this application, this containment is quicker to assemble than traditional speed rails and shrink wrap type of containment. It is also less likely to be breached while blasting. This ridged containment is built in 4' x 4' sections and incorporates a personnel access door, plexiglass viewing window, interior lighting, and ventilation equipment access.

**Installing pump bowl containment at Eagle Unit 9 (left), and a look inside the containment (right)**

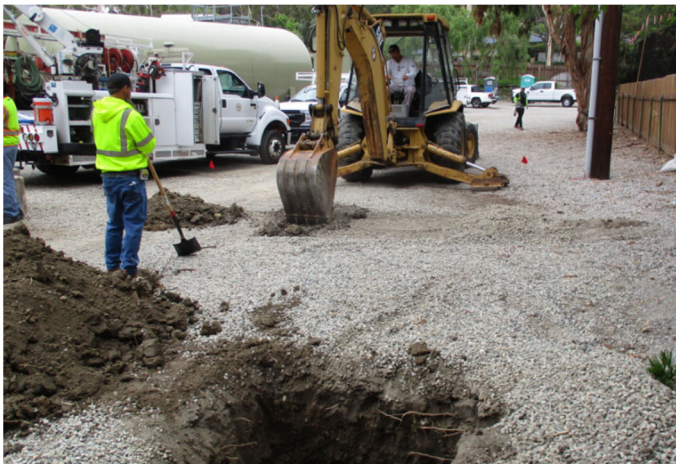
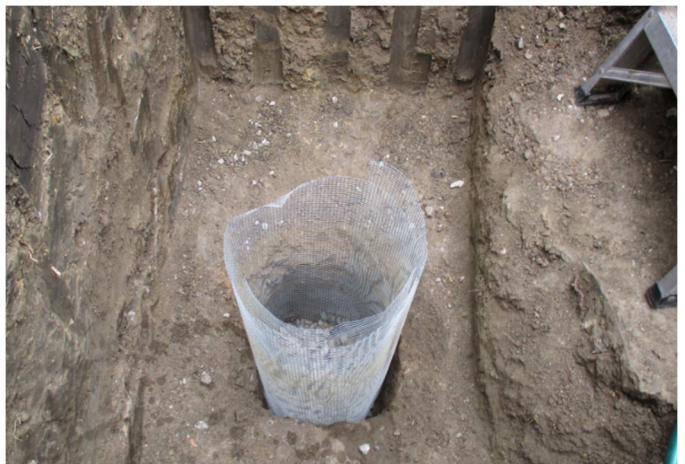
Staff began installation of an infiltration basin and drainage piping to capture the Service Connection WB-06 Valve Structure sump pump discharge water. Installation of this basin will allow the sump pump drainage water to percolate into the soil and eliminate water discharge onto the public street.

**Excavating for percolation test pit (left) and conducting percolation test (right)**

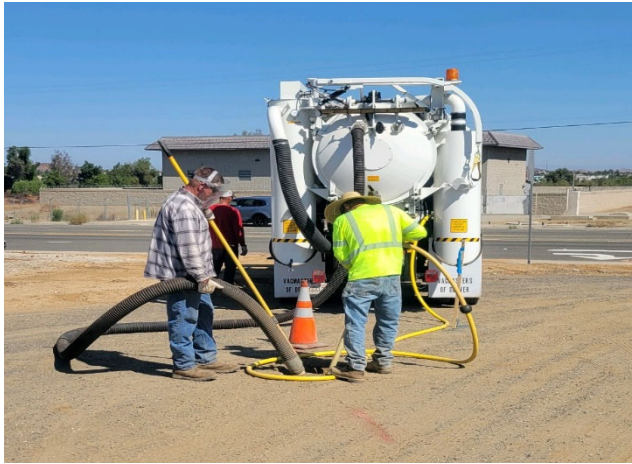
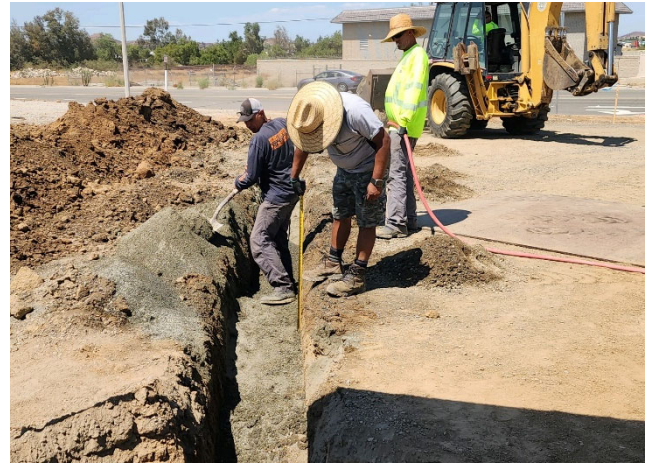
Staff completed the installation of new communications infrastructure on the Auld Valley Pipeline as part of a SCADA Network upgrade to enhance network reliability and security. The local utility service provider will install a new fiber communications line to complete the project.

**Potholing for existing utilities (left) and backfilling over new conduit for fiber optic cable (right)**

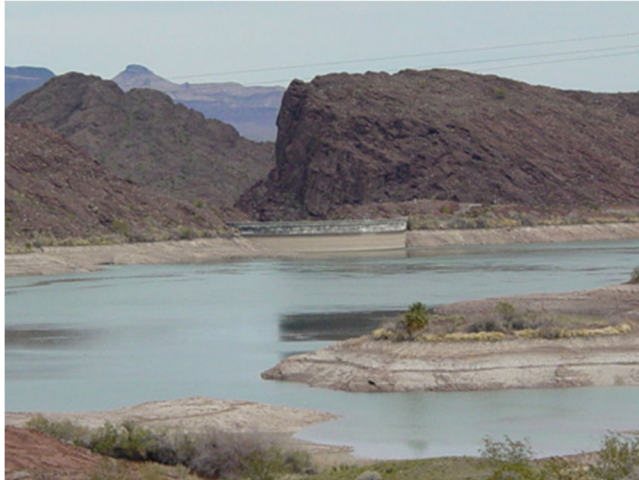
The La Verne Shops completed an inspection of the inlet side of the Gene Wash Dam fixed cone valve using an underwater remote-operated vehicle (ROV). The valve, which is submerged 100 feet under water, will be operated next month to perform a full-flow operational test. The inspection was completed to verify there was no large debris or obstructions on the inlet side of the dam's fixed cone valve.

Gene Wash Dam (left) and plan view of valve location (right)

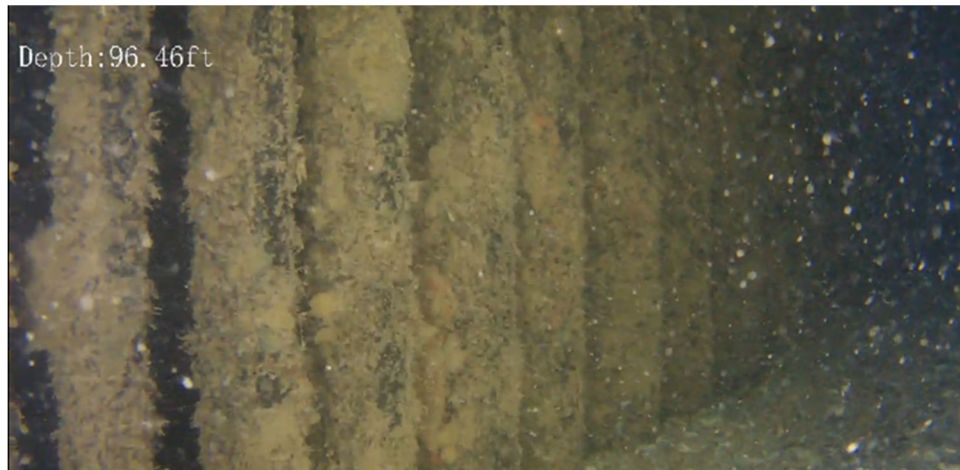
Inspection of valve inlet trash rack

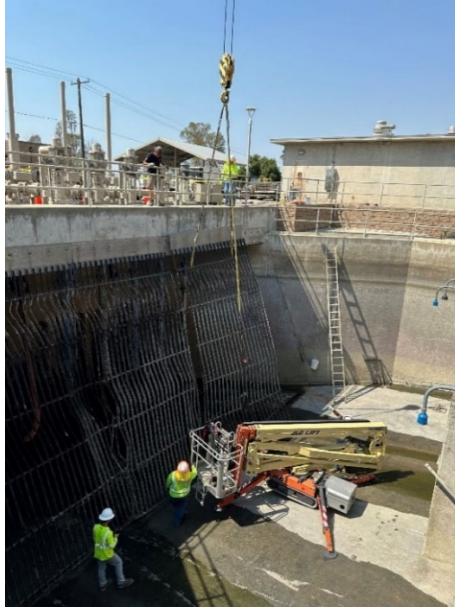
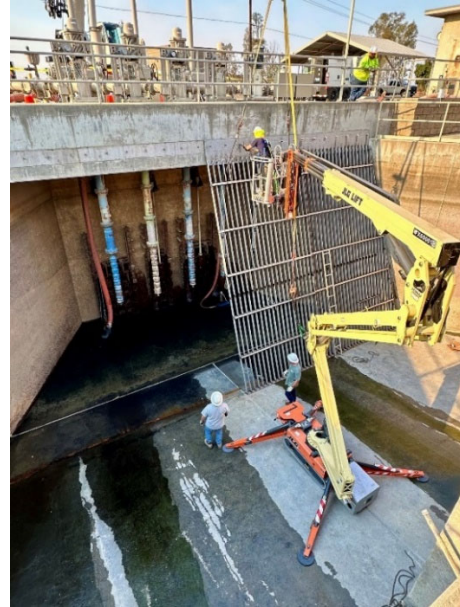
Staff completed installation of a new trash rack for the East Lake Skinner Bypass structure. This structure transitions the San Diego Canal into raw water pipelines that feed San Diego County Water Authority. Metropolitan staff built and installed the trash rack that is used to prevent debris from entering the San Diego pipelines while the lake bypass is in operation.

**Staff installing a new trash rack at the East Lake Skinner Bypass**

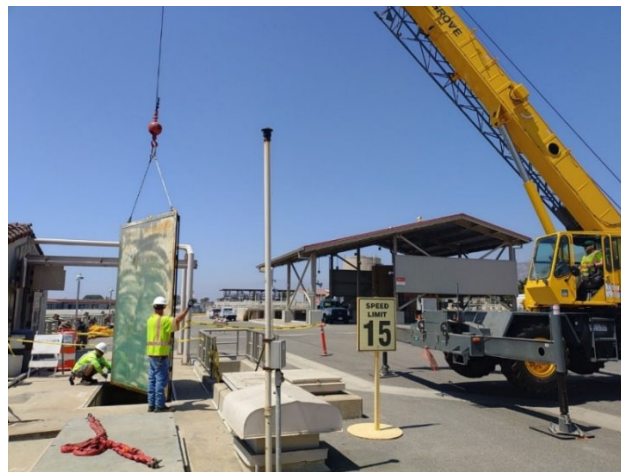
The Weymouth Mechanical Team installed two drop gates that isolated six filters from service. The filters were isolated and removed from service to allow staff to replace the influent and effluent valve on one for the filters. Following the valve replacement, plant staff worked with water quality staff to complete disinfection and bacteriological testing of the filters prior to being placed back into service. Over the next 12 months, a similar procedure will be followed to replace additional filter valves as part of the Weymouth Basin 5-8 Rehabilitation capital project.

**Mechanics removing filter effluent channel drop gate at the Weymouth plant**

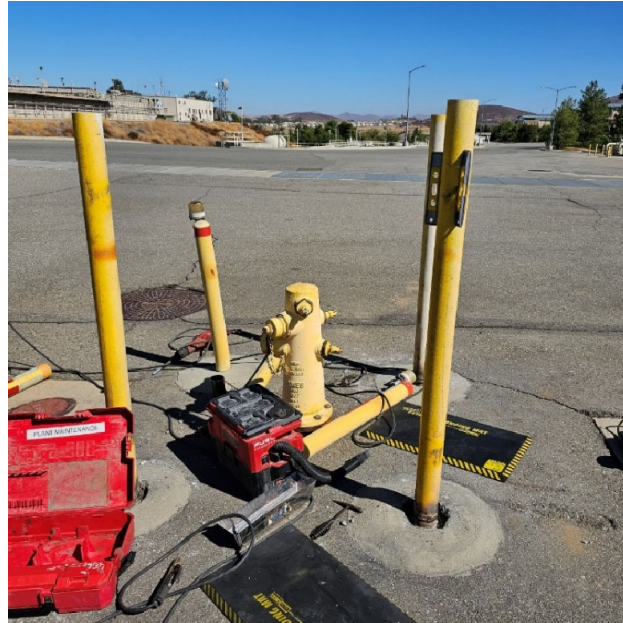
Skinner staff replaced existing bollards surrounding a fire hydrant in a high traffic area with taller bollards. This will improve safety by increasing visibility of the protective devices when traveling through the area, as the shorter bollards have been hit in the past.

**Replacement of bollards protecting fire hydrant with new, taller bollards for increased protection and visibility**

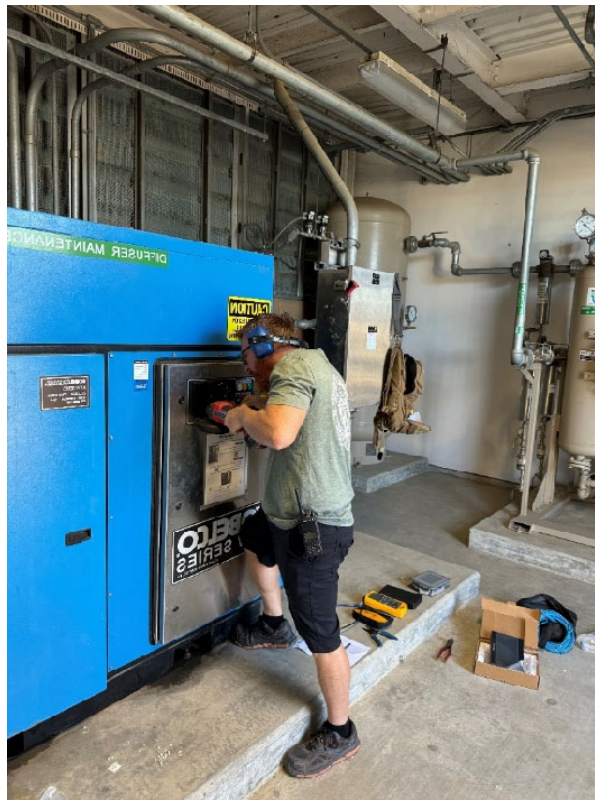
Staff installed a new Human Machine Interface (HMI) on the local control panel of the Ozone Contactor maintenance air compressor system. A Human Machine Interface (HMI) serves as a user interface that allows humans (staff) to interact with machines and/or systems by providing a visual way to monitor and control processes. The HMI essentially acts as a bridge between the operator and the machine, simplifying complex operations and improving efficiency, safety, and productivity through intuitive displays and controls. This installation enhances the local monitoring and troubleshooting capabilities for the critical air compressor system, which is essential for purging residual ozone gas when the system is taken out of service, ensuring a safe environment for workers.

Staff installing Human Machine Interface (HMI) for interactive control and data related to the ozone contactor air compressor system
