Engineering, Operations, & Technology Committee

Update on Jensen Reliability Projects

April 10, 2023

Jensen Reliability Upgrades

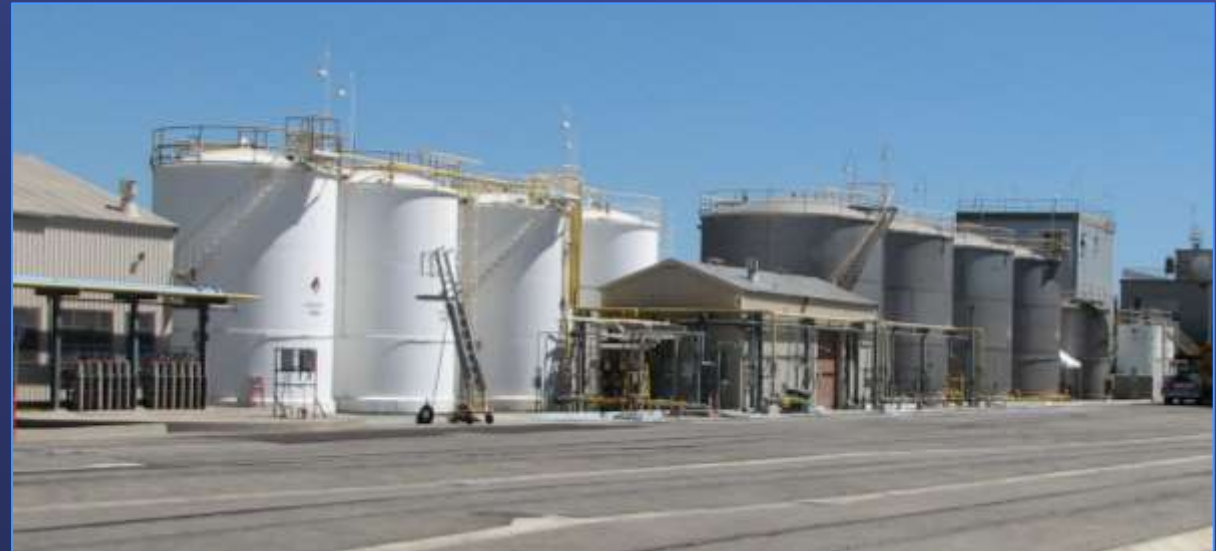
Existing Jensen Caustic Tank Farm

- Existing caustic tank farm
 - Original from 1972
 - Previous containment retrofit does not meet current Metropolitan standards

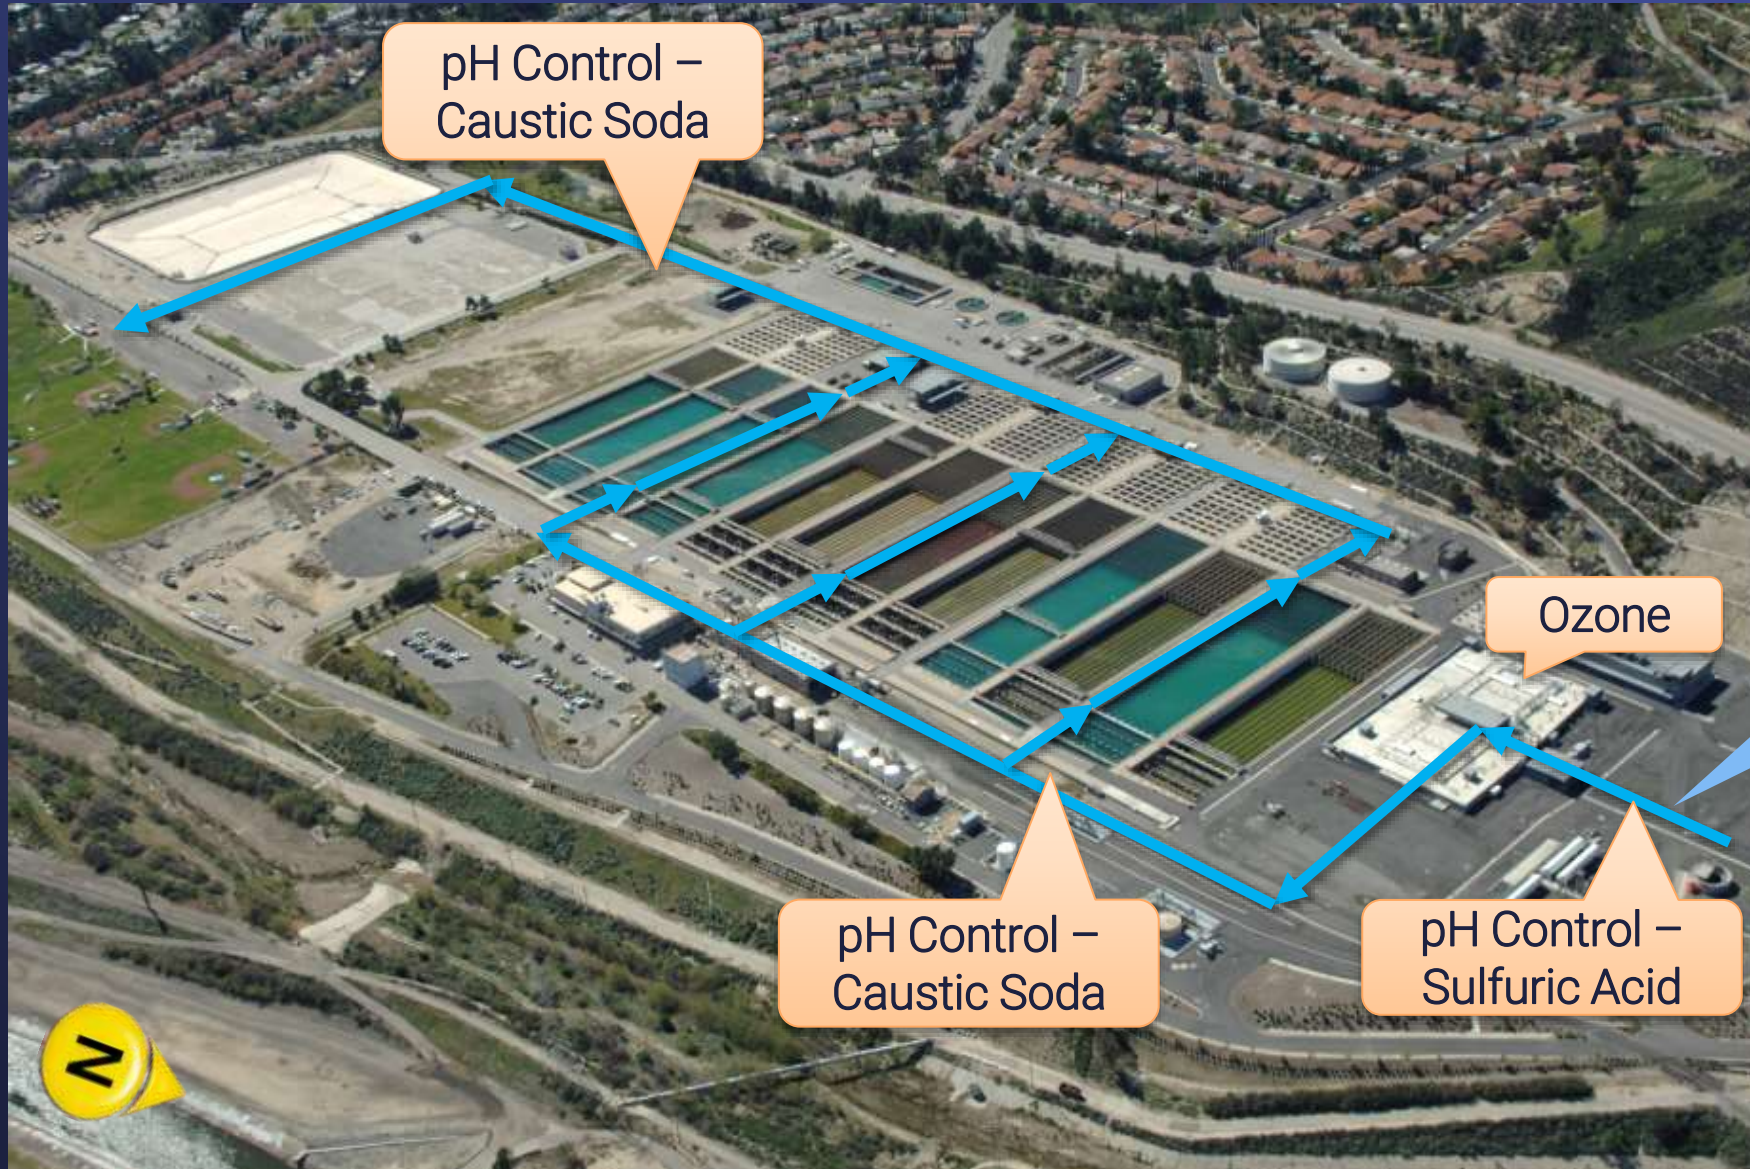
Enhanced Bromate Control Process

- Caustic soda price increasing
 - Project cost reduced by integrating ammonia-chlorine process for bromate control

*Ammonia-chlorine bromate control process has been effectively implemented at the Mills and Weymouth plants

- Ammonia and chlorine added upstream of ozone contactor
 - Effectively controls bromate
 - Reduces chemical costs
- New caustic soda tank farm adjacent to plant outlet
- Removal of decommissioned tank farm

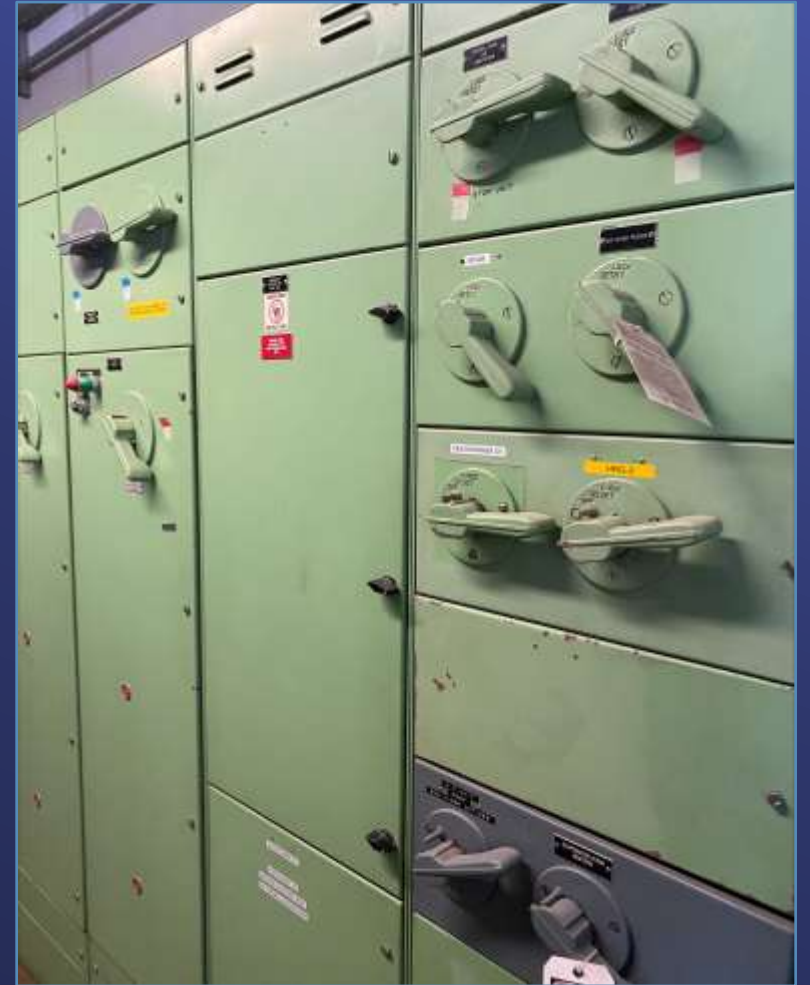
Original Plant Equipment from 1972

- Additional power supply needed for key treatment processes
 - Chlorine
 - Coagulants
 - Flocculators
 - Finished Water Reservoirs
 - Administrative Building
- Standby 480V generators can power equipment during emergency
- Double-ending power completed at Diemer, Skinner, and Weymouth plants; underway at Mills plant

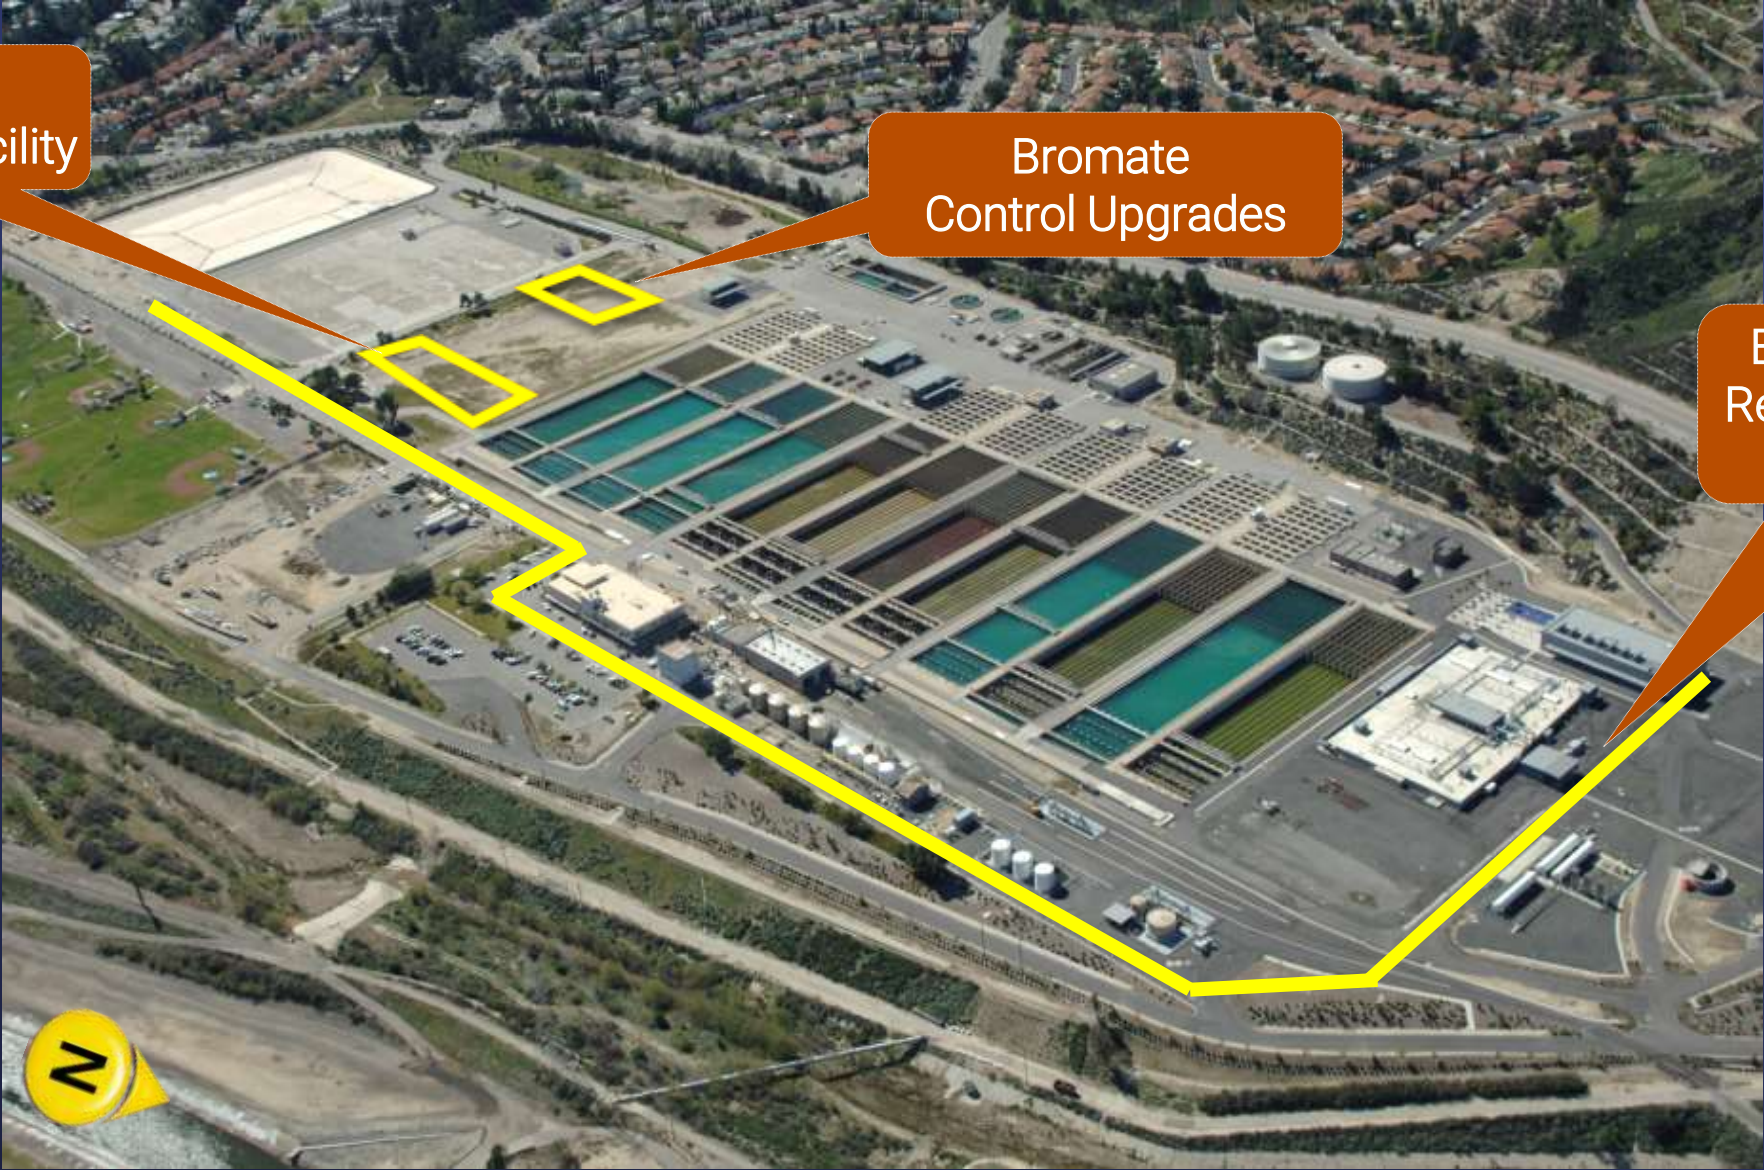
Upcoming Reliability Projects

Mechanical
Dewatering Facility

Bromate
Control Upgrades

Electrical System
Reliability Upgrades
Stage 3

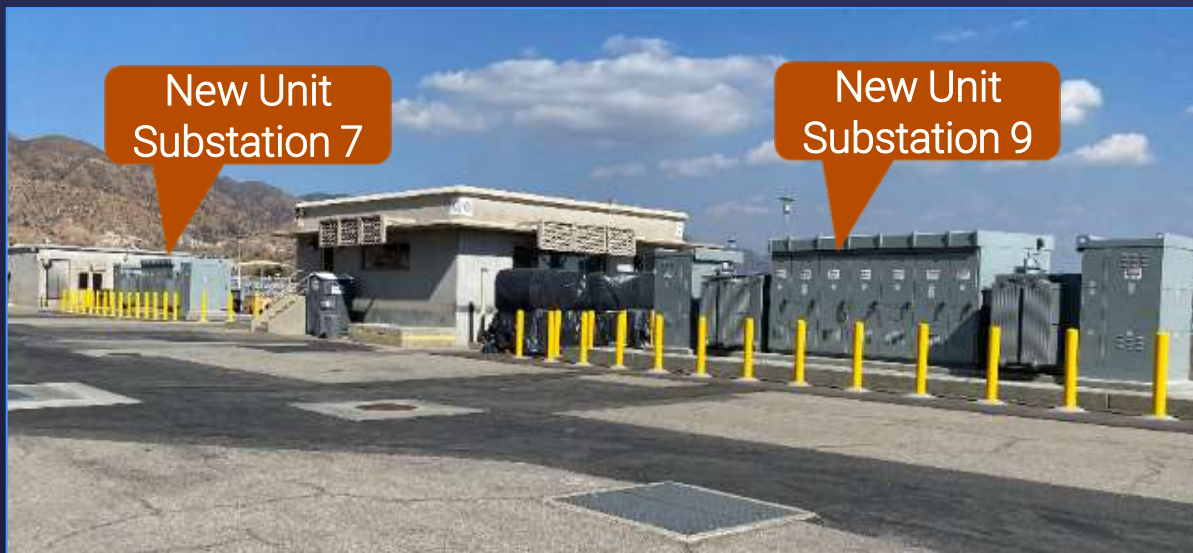
New Unit Substation

- **Stage 1:** Enhanced medium-voltage switchgear & provided electrical infrastructure for the Solar & BESS Facilities (**completed in 2018**)
- **Stage 2:** Upgraded Uninterruptible Power Supply (UPS) units and associated Motor Control Centers (MCCs) supporting critical process equipment on western portion of the plant (**completed in 2022**)

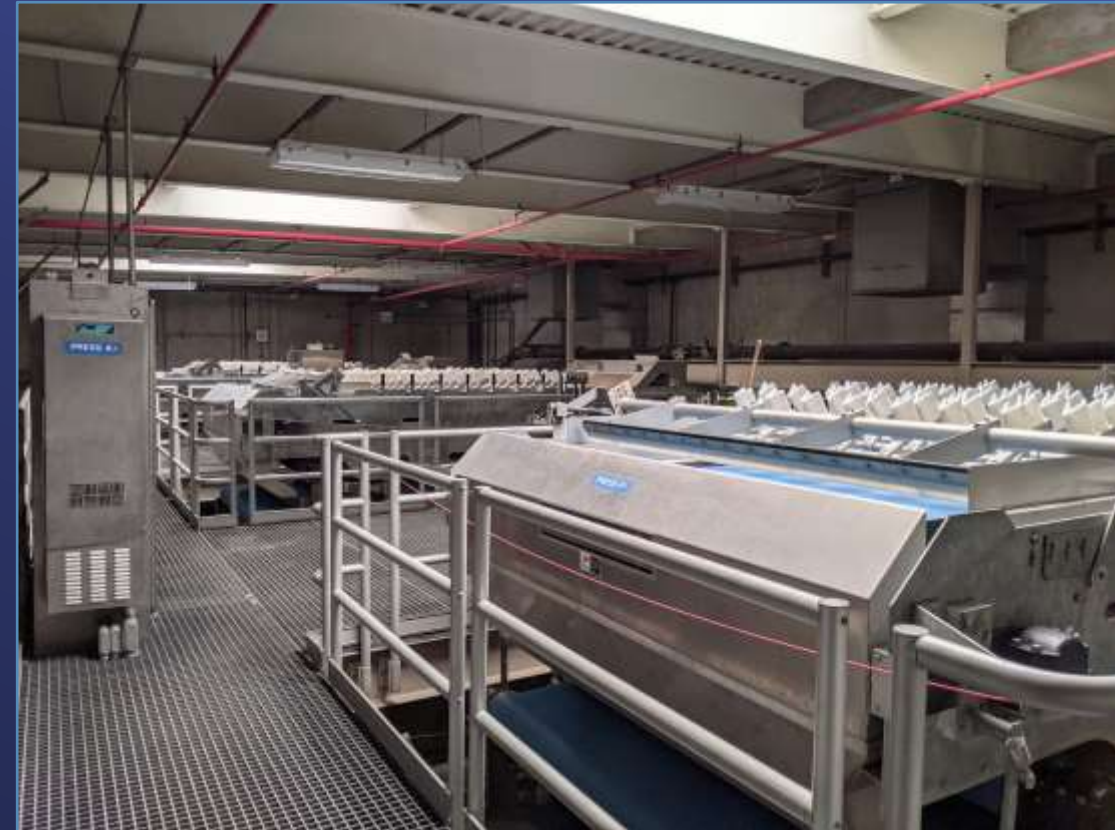
Mechanical Dewatering at Weymouth

- Long-term plan for Jensen solids handling includes both lagoons and mechanical dewatering
 - Inadequate space for lagoons to support 500 MGD and above
- Most cost-effective solution
 - Use of two existing lagoons
 - Addition of mechanical dewatering
