# Skinner Ozone Contactor Structure Rehabilitation

Item 7-6

March 13, 2023

- Award a \$394,534 contract to Slater Waterproofing, Inc. for structure rehabilitation of the ozone contactor at the Robert A. Skinner Water Treatment Plant

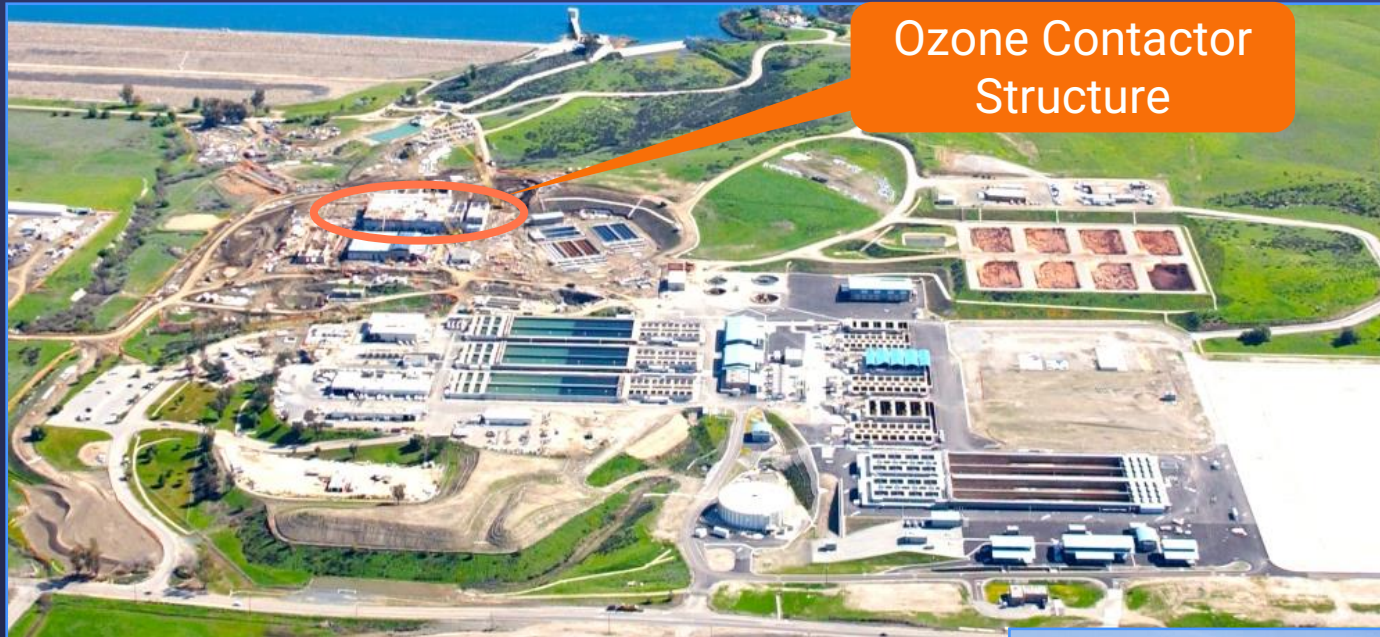
- Six Ozone Contactors
  - Each 120 ft long, 38 ft wide, & 30 ft tall
  - Each treats 60 MGD to 125 MGD

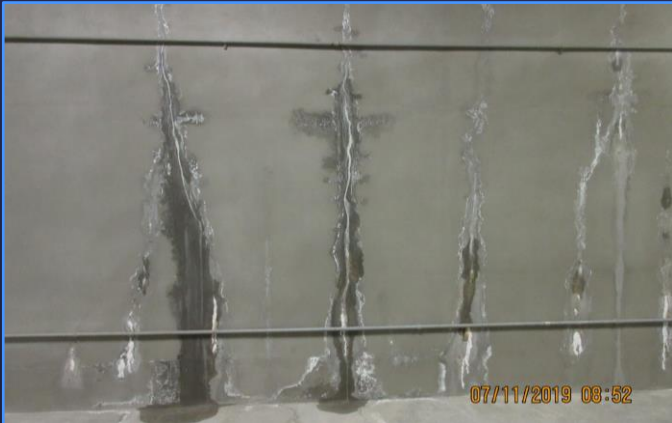
Skinner Ozone Inlet  
Channel Wall

- 2,400 ft of cracks
- Approx. 1/16 in width
- Cracking in concrete is naturally occurring & can self-seal over time
- Sometimes cracks do not self-seal which leads to water leakage
- Unrepaired cracks could lead to:
  - Steel reinforcement exposed to water
  - Corrosion may further weaken the concrete

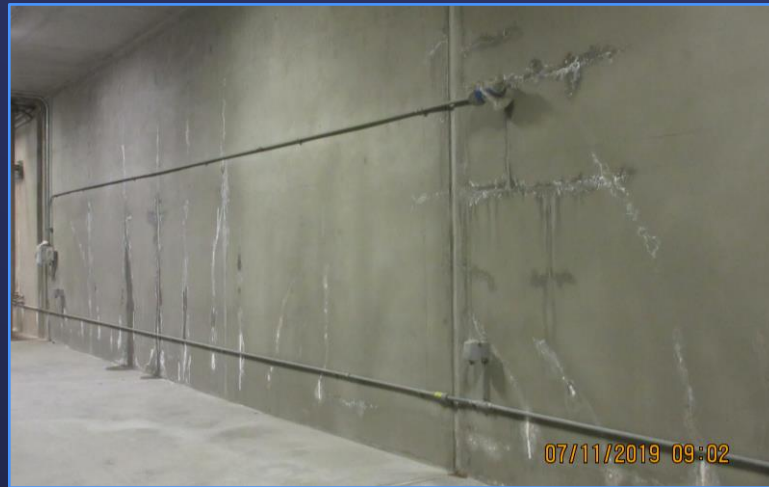
Skinner Ozone Inlet  
Channel Wall

- Contactors 3 & 4 were rehabilitated with hydrophilic grout injection July 2019
- Contactors 1 & 2 and Influent Channel are subject to this action

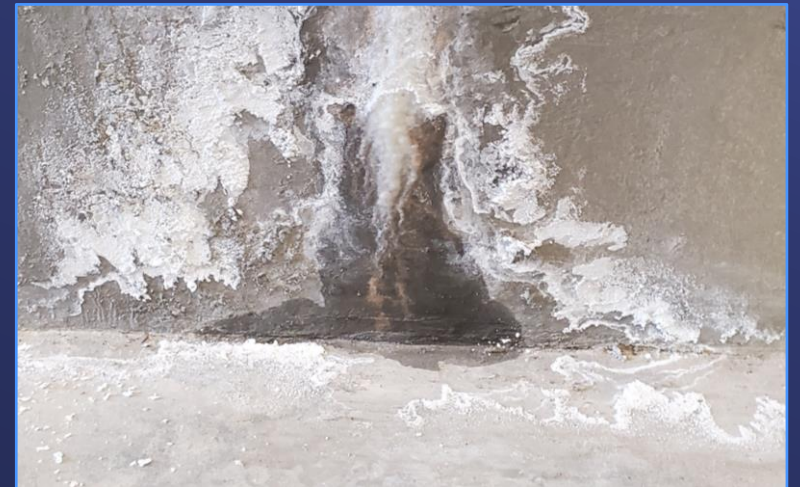
Close up of Leak on Contactor 1

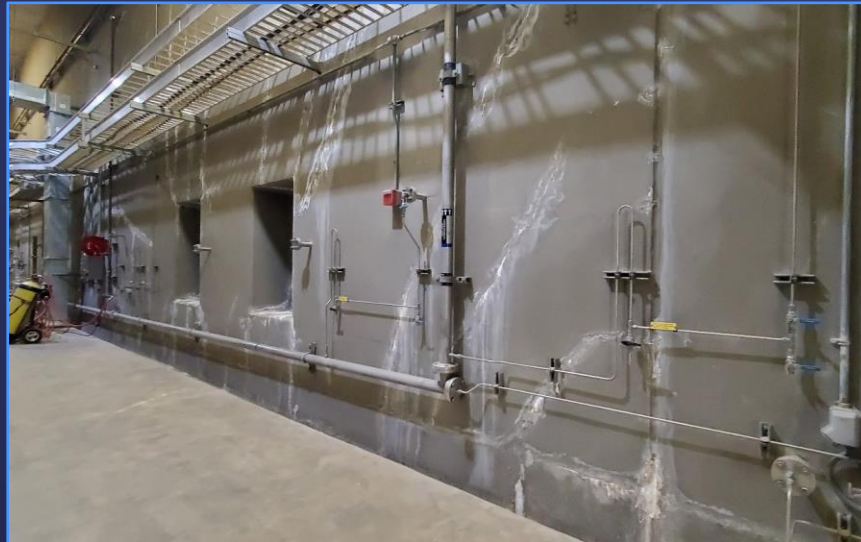
Skinner Contactor 2 Wall

- Rehabilitate the concrete walls on Contactors 1 & 2 and the Influent Channel
- Inject hydrophilic grout into existing cracks
- Place cementitious mortar as finish layer
