THE METROPOLITAN WATER DISTRICT
OF SOUTHERN CALIFORNIA

Board Report

• **January Operations Groups Monthly Activities Report - December**

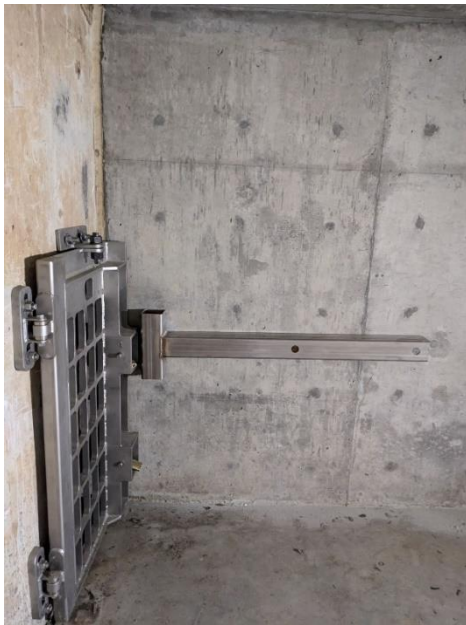
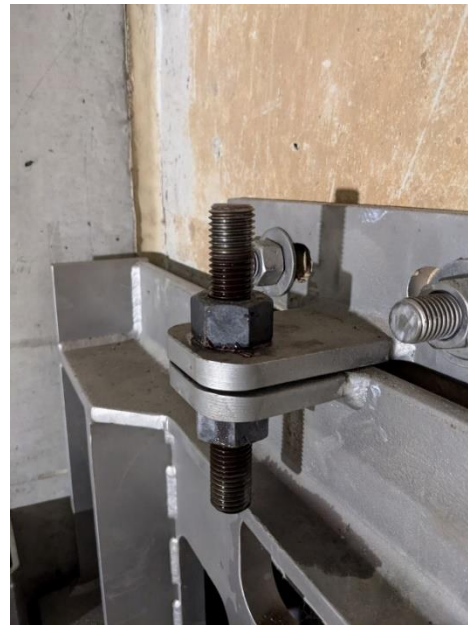
Weymouth staff made modified the plant rejection structure isolation gates to increase site security. The modifications included a door stop fastened to the interior wall, which can be removed only from within the structure. This will prevent unauthorized entry to the rejection structure from downstream flood control facilities. The new door was secured to the frame with oversized hardware, making it increasingly difficult to cut through.

Weymouth rejection structure new door stop (left) and oversized hardware (right)

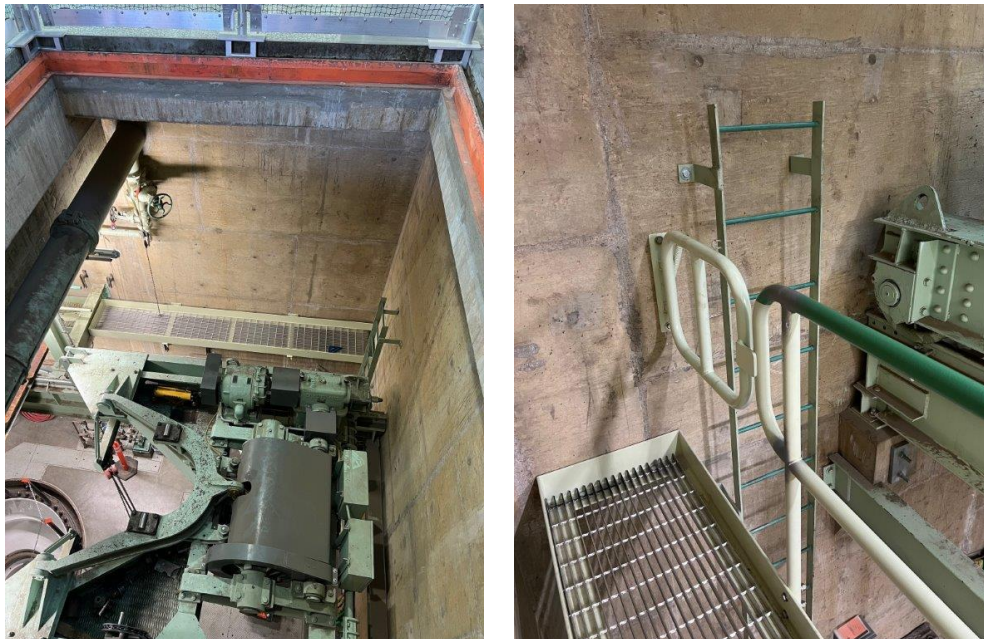
Desert staff installed an extended catwalk, handrails, and self-closing gate to improve safe access to equipment at Eagle pumping plant. This allows staff to safely access piping, valves, and associated instrumentation.

Extended catwalk for safer access to equipment (left) and self-closing gate for improved fall protection (right)

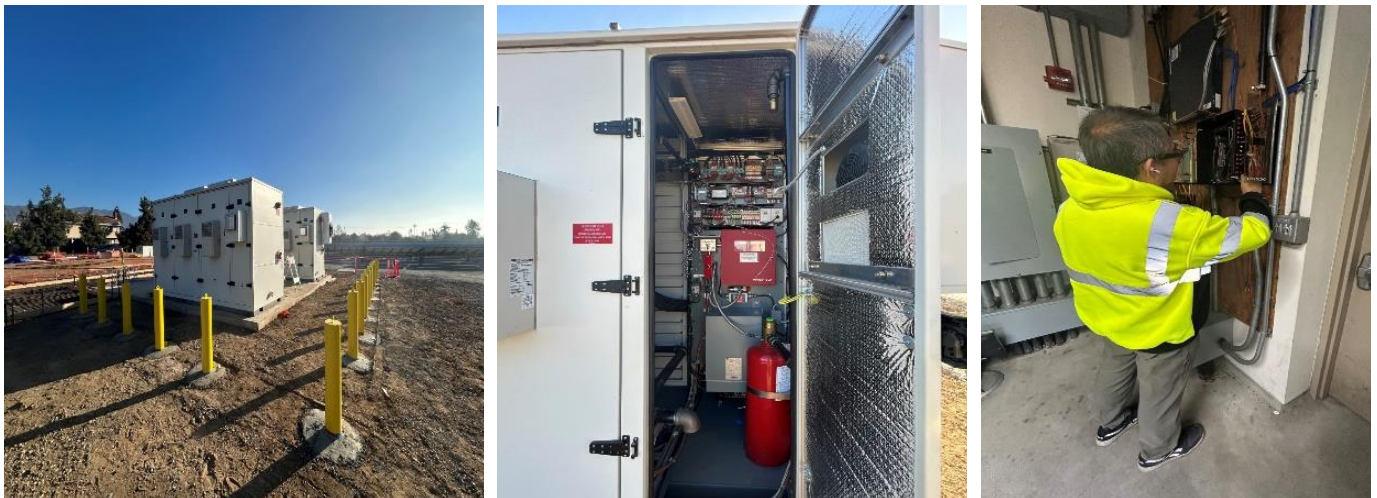
Weymouth plant staff completed fiber installations, point-to-point testing, and input/output verification on the Battery Energy Storage System (BESS) capital project. System commissioning is in progress and is expected to be completed this month. The BESS will enable the Weymouth plant to store surplus energy generated by the solar farm in a dedicated battery bank. When energy pricing is at its peak or during times when supplemental energy is needed, the battery bank can provide power to portions of the Weymouth plant—improving energy efficiency and lower operating costs.

BESS near Weymouth plant solar farm (left), BESS control panel (middle), and staff interfacing BESS to SCADA network (right)

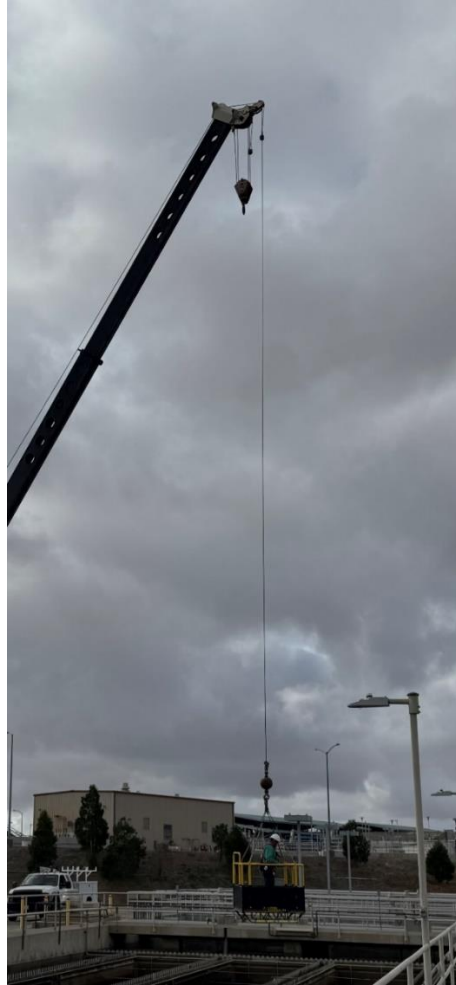
Skinner plant staff began the process of removing the horizontal supports for the sedimentation basin launders at the washwater reclamation plant, as the existing launders are at the end of their service life and undergoing replacement. The launders collect and direct clarified water from the reclamation plant sedimentation basin to the pump back, where the reclaimed washwater re-enters the treatment process to ultimately become treated water.

Staff working from utility basket to replace launders at Skinner washwater reclamation plant

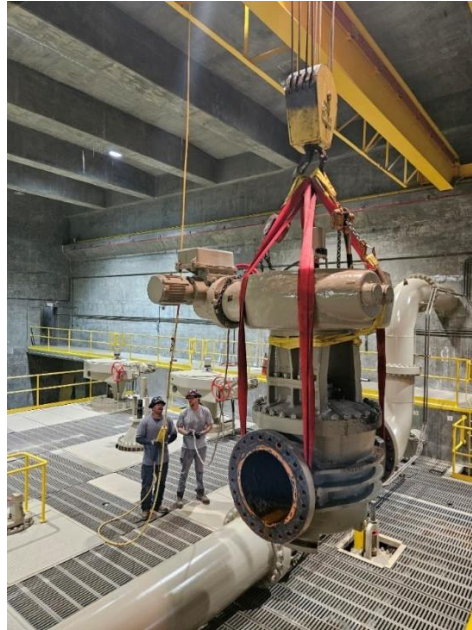
Staff removing a conical plug valve at Oak Street PCS for repair

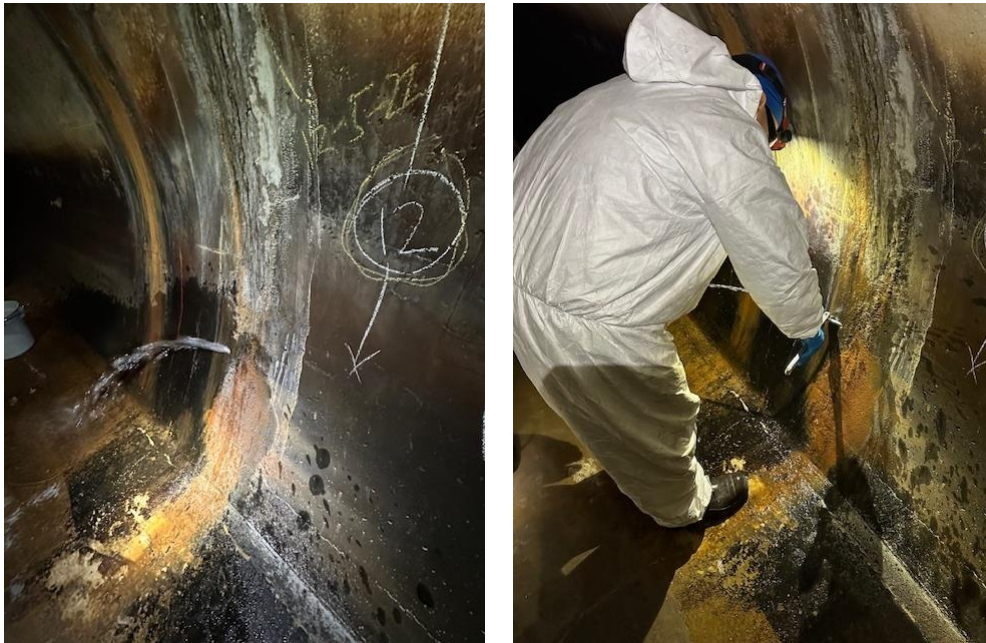
The San Diego Pipelines 1 and 2 shutdown was scheduled from December 8 through 17 to allow San Diego County Water Authority to perform repairs and maintenance within their jurisdiction. Metropolitan staff used this opportunity to inspect and make repairs inside the Rainbow Tunnel and perform an inspection on San Diego Pipeline 1. Staff sealed various water intrusion locations using high-pressure hydrophilic sealant to fill small cracks in the aging concrete.

Water intrusion (left) and staff performing repairs (right) inside Rainbow Tunnel

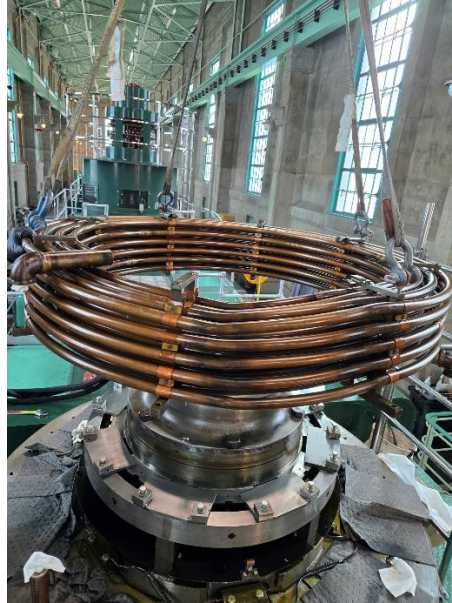
Desert staff disassembled a pump unit at Intake pumping plant to repair a water leak. Cooling water is used to keep the bearing and lubrication oil for the main pumps cool during operation. The copper cooling coils can fail over time, which leads to water contamination of the oil. Staff must repair the cooling water coils to maintain oil integrity needed to preserve reliable pump operations.

Removing pump unit cooling coil for repair

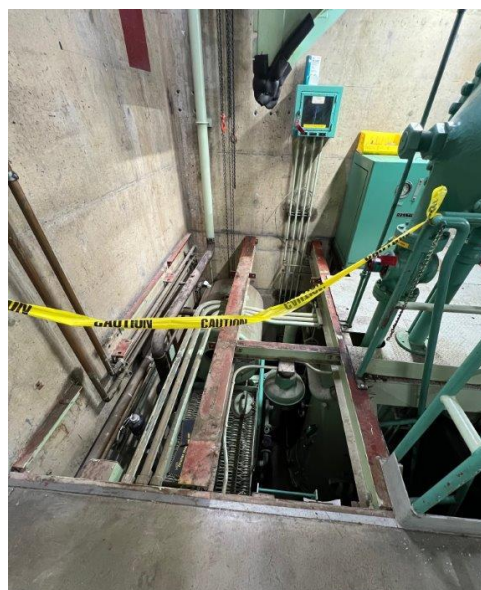
Desert staff continues work on repairing a pump unit at Eagle pumping plant. In addition to motor testing and repair, an inspection of the lubrication system revealed failing coating in the oil sump tank. Staff removed the sump tank and transported it to the La Verne Shops for repair.

Pump unit repair at Eagle pumping plant

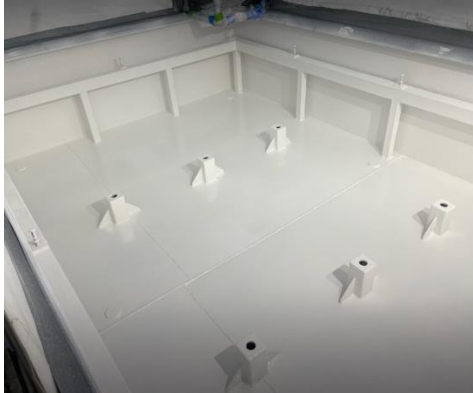
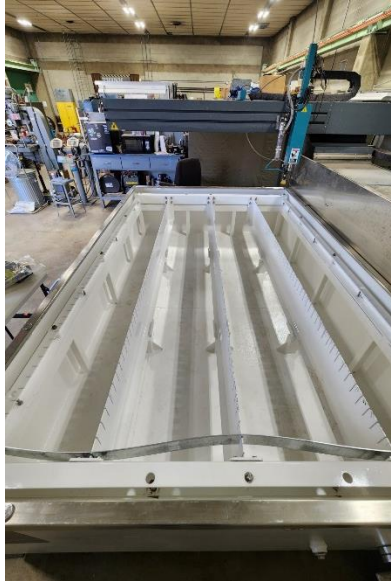
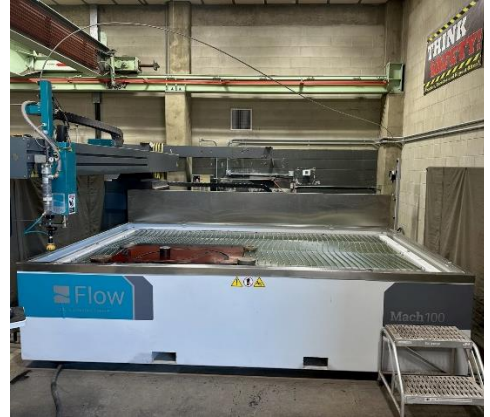
Desert staff made repairs and refurbished the machine shop water jet machine located at the Gene facility. This unit is vital for manufacturing components not readily available for purchase, an increasingly common occurrence as the CRA systems continue operation past their useful life. These water jet machine units require periodic maintenance such as tub coating and support web replacement.

Empty tub (left), tub recoating completed (center), and water jet tub repairs completed (right)

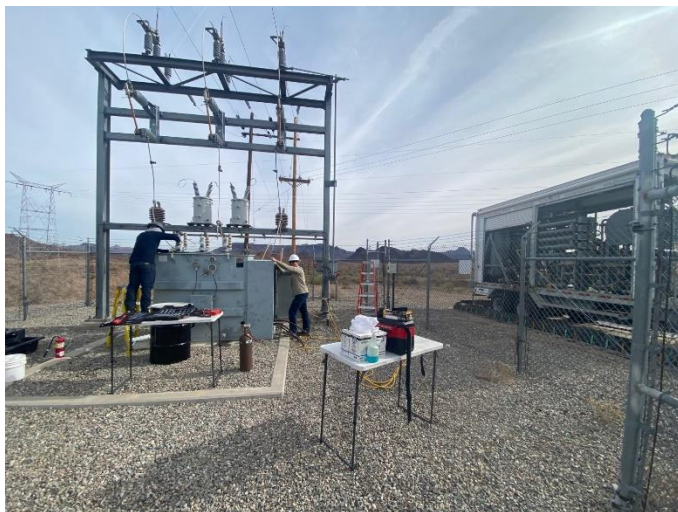
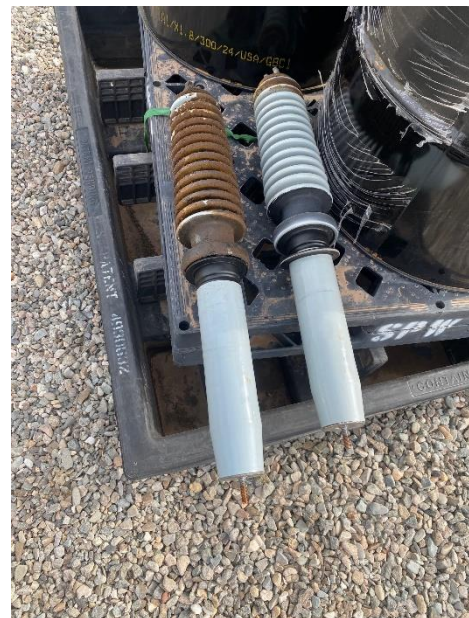
Desert staff identified and replaced leaking high-voltage electrical bushings on the Gene-Peddler transmission line. These devices isolate high voltage within transformers and allow for connection points to the device.

Gene-Peddler Line electrical testing and bushing replacement

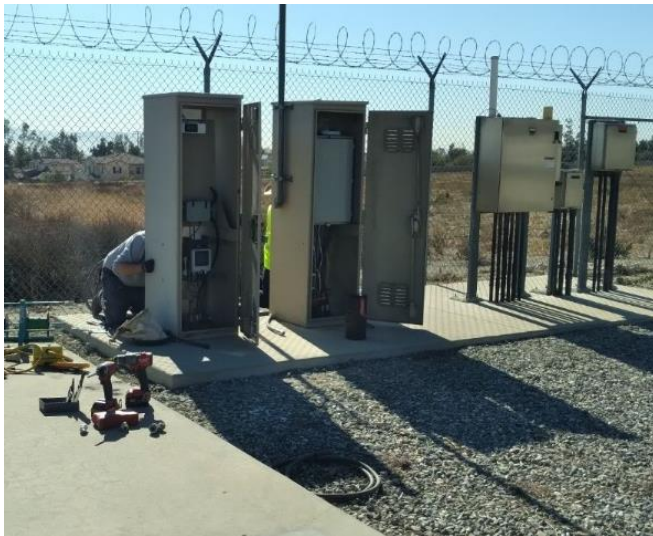
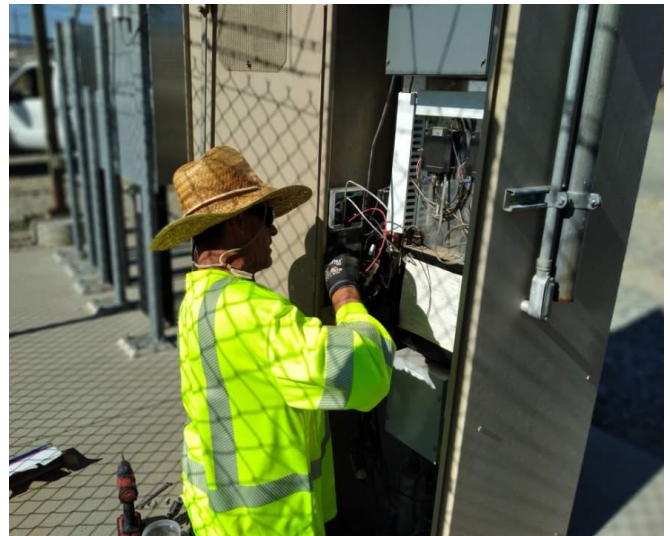
Numerous remote structures throughout Metropolitan’s service area depend on outdated copper wiring for alarms and communication. These lines are being upgraded to new fiber optic cable, which will provide higher bandwidth, enhanced security capabilities, and improved reliability in areas that have historically experienced communication issues. Recently, a crew completed work at the CB-14 Service Connection structure on the Rialto Feeder (and will proceed to other locations within the Orange County region).

Staff modifying cabinets for the new communication equipment

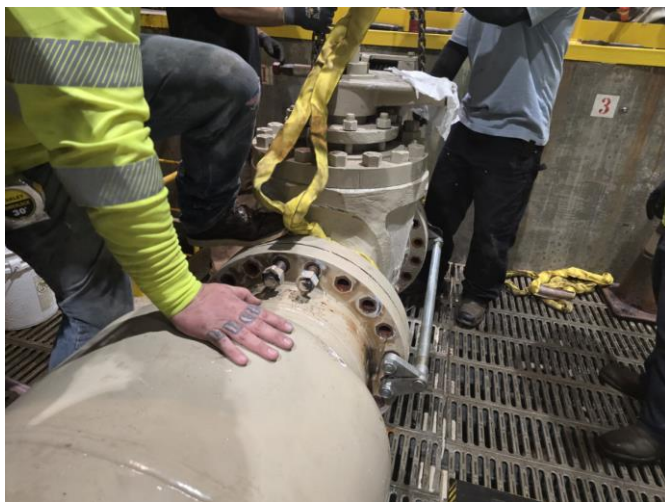
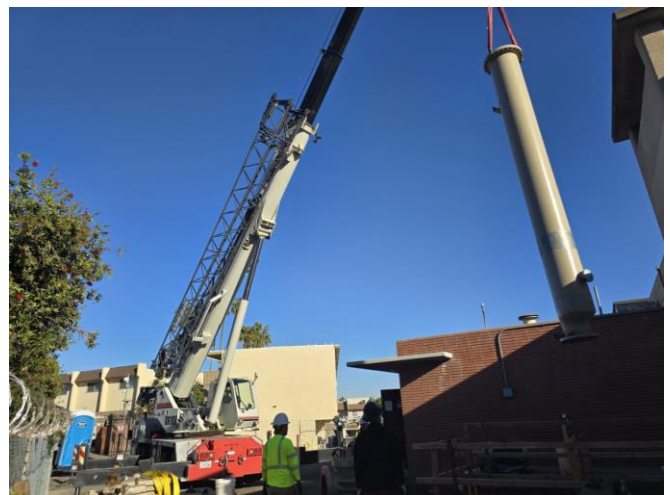
Staff began the replacement of a 16-inch diameter lubricated plug valve and a 24-inch check valve at the Oak Street Pressure Control Structure located on the Second Lower Feeder. As part of this work, staff removed a pipe section and transported it to the La Verne Shops for modification. Upon completion, staff will reassemble the piping with a new restrained coupling to fit new valve installations.

Staff dismantling pipe section (left) and hoisting pipe section out of Oak Street PCS (right)

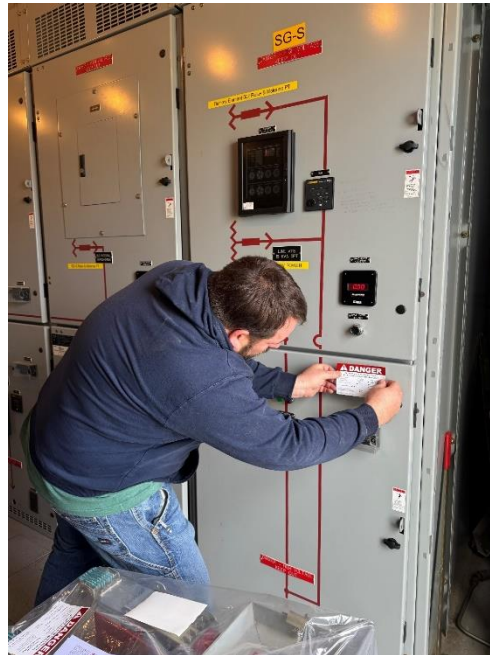
Staff applied arc flash hazard labels to electrical equipment throughout the Skinner plant. The labels indicate the hazard present at each point in the electrical distribution system, as modeled by computer analysis using data points from electrical devices such as transformers, circuit breakers, and cables. The labels allow electrical workers to identify inherent dangers and determine the appropriate level and type of personal protective equipment needed to stay safe in the event of an arc flash event.

Staff adhering arc flash hazard labeling to electrical equipment at the Skinner solar facility

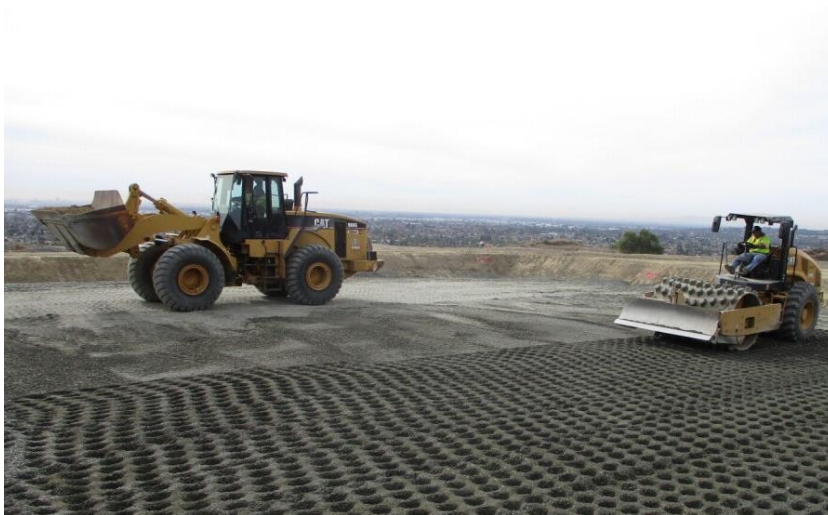
Staff continued construction for the Diemer Helicopter Hydrant Facility. The helicopter hydrant consists of an open-top tank and supporting infrastructure, allowing helicopters to quickly collect water to fight nearby fires. Metropolitan collaborated with Yorba Linda Water District (YLWD) to develop a project that would benefit both agencies. YLWD will provide up to \$500,000 in grant funding, technical support during design and construction, and coordination with the California Department of Forestry and Fire Protection and Orange County Fire Authority. Metropolitan will own and operate the facility after construction is completed.

Staff compacting base rock for the helipad at the Diemer plant
