THE METROPOLITAN WATER DISTRICT
OF SOUTHERN CALIFORNIA

Board Report

Water System Operations Group

• Operations Monthly Activities for March 2024

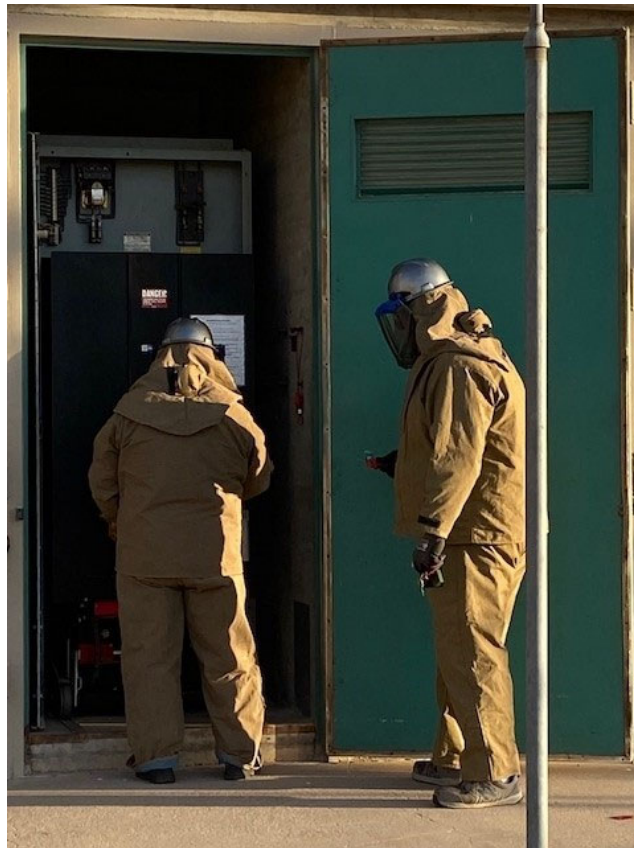
Staff racking out a 6.9kV circuit breaker at Gene pumping plant

Safely isolating equipment from possible hazards is often the first step in maintenance. Working with high-voltage electrical circuits requires proper training and PPE. High-Voltage Switching and System Operating Orders Manual (SOOM) training refresher classes are held annually to ensure staff safety.

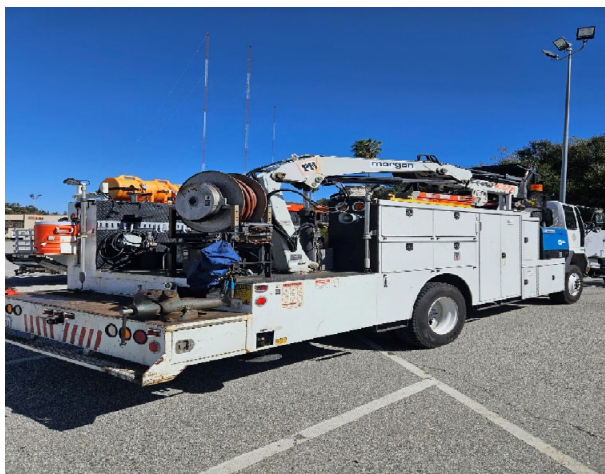
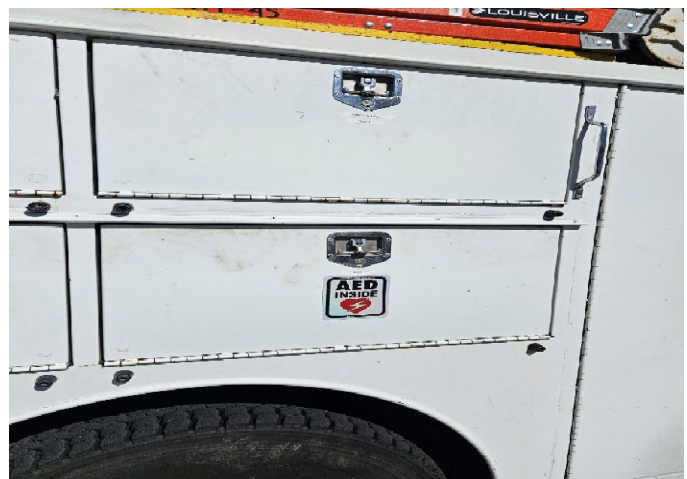
Field utility truck equipped with AED

During a field Safety Quarterly Committee meeting, staff suggested installing an Automated External Defibrillator (AED) on four utility trucks. The utility trucks are used during large field jobs and shutdowns where various employees are working together. An AED is used by a certified staff member to help someone experiencing a sudden cardiac arrest. If an AED is ever needed, staff now has ready access to it.

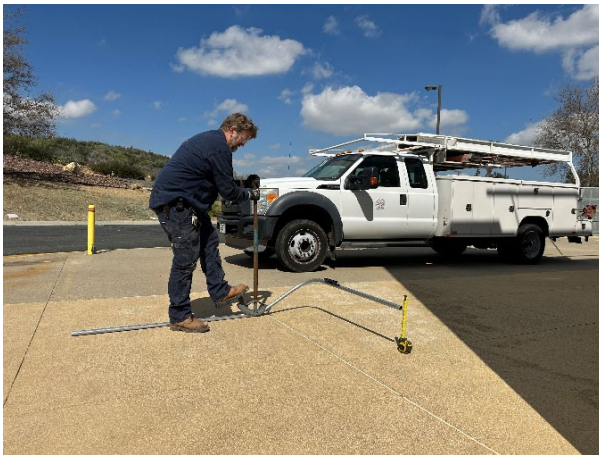
Conduit preparation (left) and electrical apprenticeship trainer (right)

Staff began work on the modifications to the new Electrical Apprentice classroom that will be located at the former Diamond Valley Lake (DVL) Visitor Center. The previous location was at the DVL Administration building. In the new space, the apprentices will have increased room, leading to a better training and learning environment. The work includes installing new receptacles for the electrical apprenticeship trainers and emergency shut-off switches for safety.

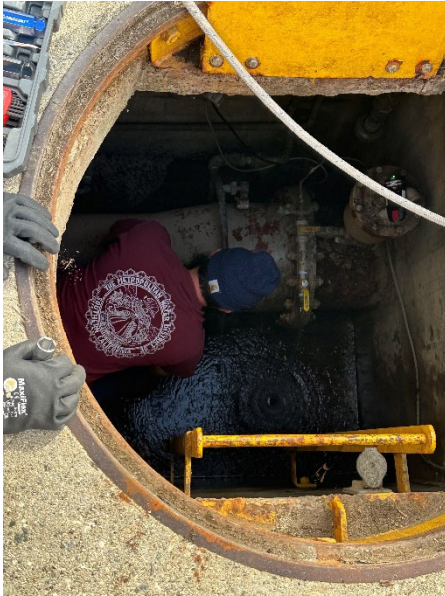
Staff performed inspections of member agencies' billing meter connections. Items inspected included venturi tubing, instrumentation connections, valve fittings, Victaulic ports, and overall meter condition. Billing meters are inspected, serviced, and calibrated at least annually for accuracy. During the Upper Feeder Shutdown, staff was able to perform a more extensive maintenance service on the billing meters that were out of service.

Staff replacing Victaulic meter port

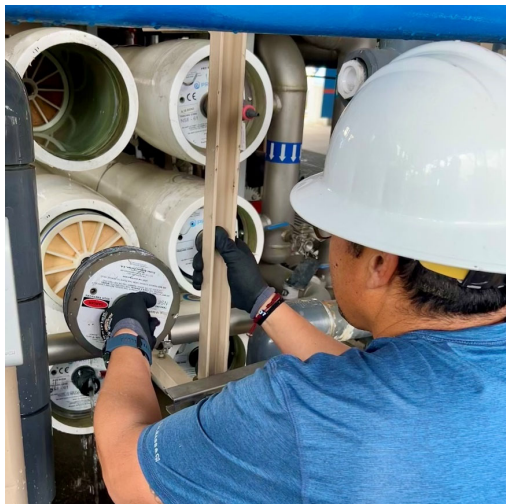
During March staff began baseline monitoring for tertiary membrane bioreactor (MBR) nitrification-denitrification testing at the Napolitano Innovation Center demonstration plant. Following cleaning of the reverse osmosis (RO) membranes in February, staff achieved stable operating conditions at the target conditions for RO concentrate characterization. Staff also continued to optimize the carbon dosing system to efficiently achieve MBR filtrate nitrate targets. Monitoring of source water, RO concentrate, product water, and key intermediate process locations was completed for a thorough characterization of treatment performance of the treatment train.

Staff installing a new RO membrane at the demonstration plant following an extraction for analysis

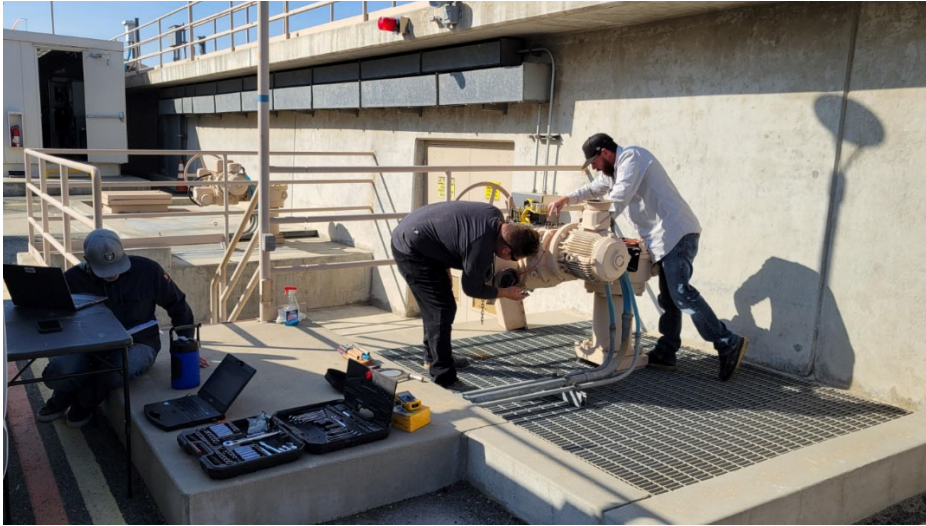
The Mills plant recently underwent a zero-flow condition which allowed Department of Water Resources (DWR) the ability to isolate the second afterbay at Devil Canyon powerplant to repair a minor leak on a bypass line. Mills plant took this opportunity to perform preventative maintenance on several systems not normally available.

Staff troubleshooting contactor inlet butterfly valve (left) and new turbidity meters installed in the cross tunnel (right) at the Mills plant

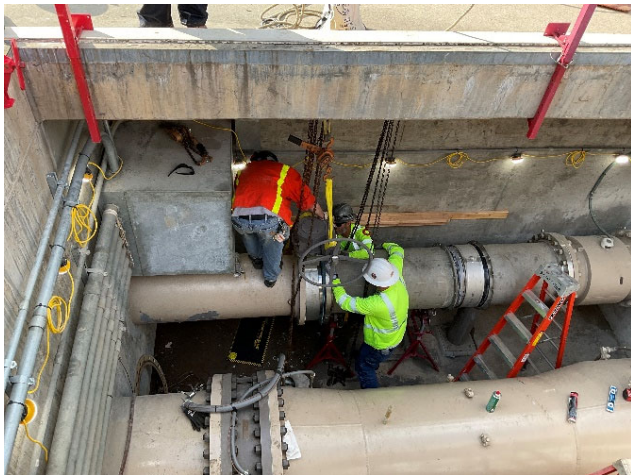
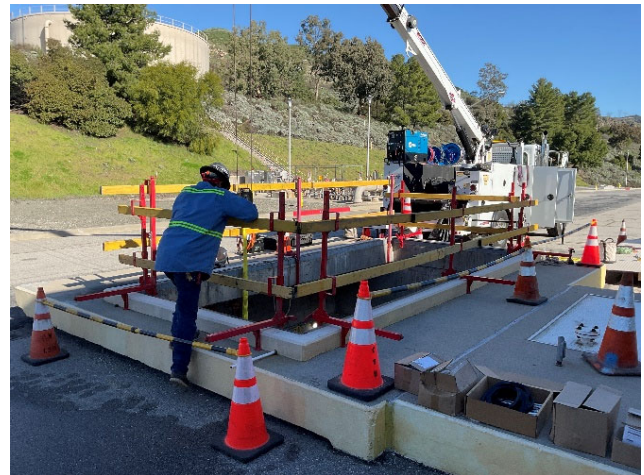
Staff completed the replacement of the Module 1 surface wash valve at the Jensen plant. This work was required to address an actuator anomaly. Pre-shutdown work included installing temporary support and scaffolding, cutting welded support, and installing anchoring to limit the shutdown duration and optimize plant production. The shutdown work included removing the structure lid, removing and hoisting the defective valve and dresser coupling, and installing a temporary replacement valve while the original valve is being repaired.

Staff installing replacement valve (left) and hoisting valve with truck crane (right) at the Jensen plant

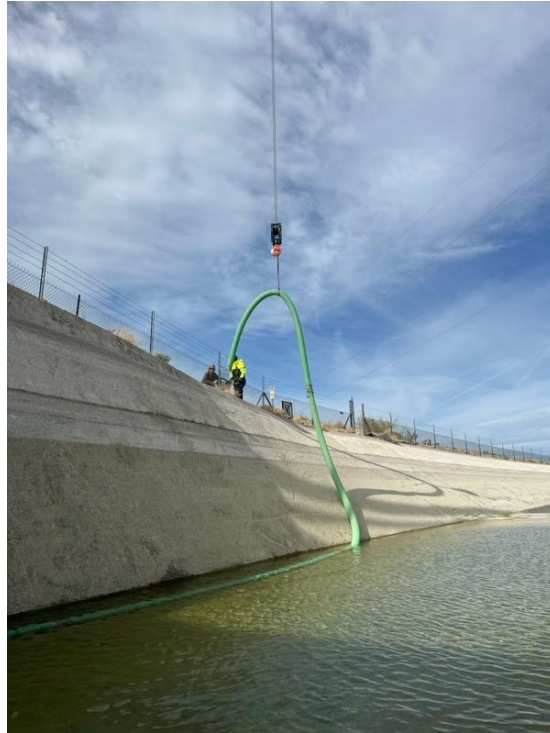
Dewatering the CRA requires planning, resources, and collaboration. Once the Copper Basin gates are closed, the Iron, Eagle, and Hinds pumping plants pump as much water as possible to minimize dewatering efforts. Radial gates are then used to release the excess water, and portable pumps are used for siphons and other low points along the aqueduct.

Staff dewatering the CRA using portable pumps

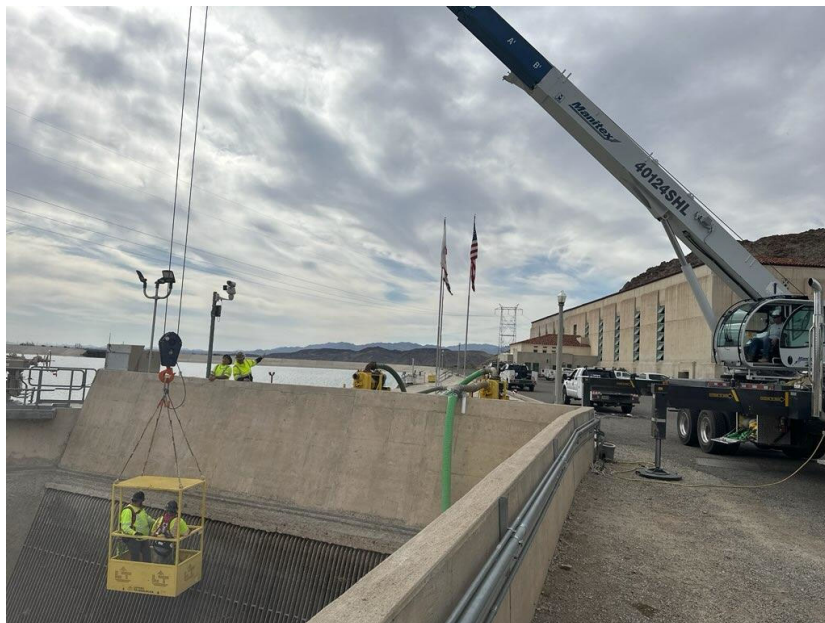
The layout of the CRA is open and allows for debris and sand to be blown into the canal during windy periods. Trash racks are used to collect the debris and prevent pumps and other equipment from becoming clogged. At the Eagle Mountain pumping plant, staff removed the trash racks to provide access for dredging and removal of sediment.

Staff removing trash racks at Eagle Mountain pumping plant

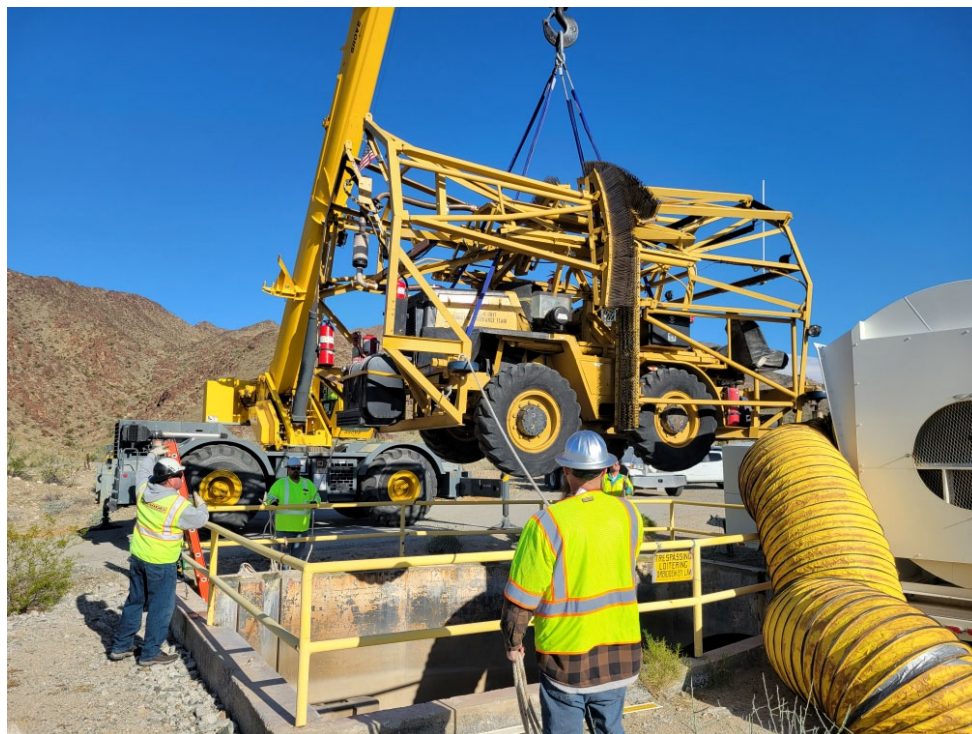
The tunnel cleaning machine was designed and built by Metropolitan. The custom-made machine is used to clean surfaces of the CRA tunnels to ensure that the aqueduct can be operated at maximum flows with minimum elevations throughout the year. During the 2024 shutdown, approximately 97 miles of tunnels were cleaned.

Tunnel cleaning machine being lowered into the CRA

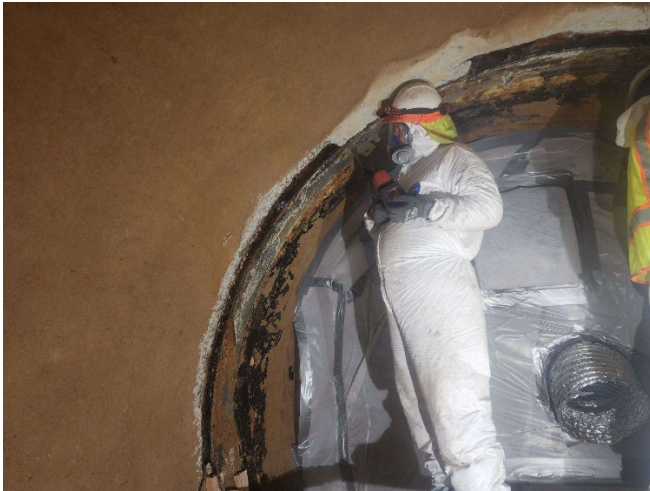
Metropolitan's concrete structures require minimal maintenance; inspection and repair efforts are performed each year. At the Eagle Mountain pumping plant, the transition point between the steel delivery lines and the concrete structure is being rehabilitated. This work requires removal of the existing joint compound, surface preparation, and application of new sealants and coating to ensure the long-term reliability of the joint.

Staff repairing transition joint at Eagle Mountain pumping plant

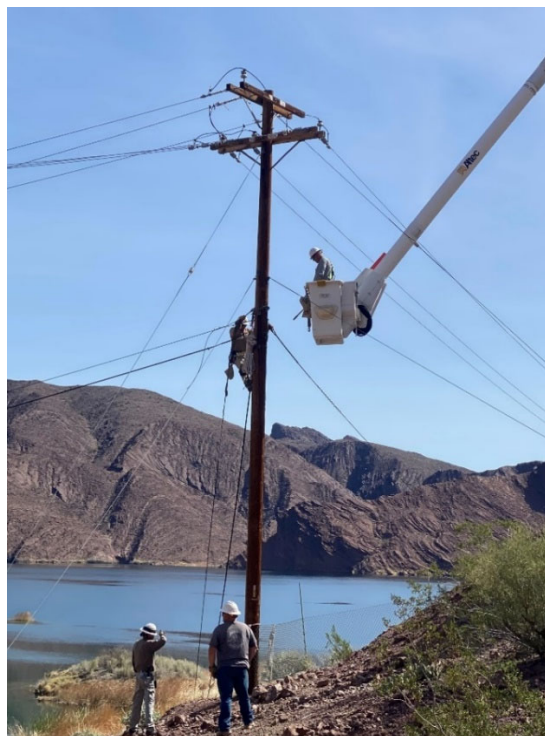
Repair work at the Copper Basin outlet structure required deenergizing the 2,300V electrical circuit. Staff isolated the circuit to allow for a mobile crane to facilitate the repair to a slide gate.

Staff isolating a 2300V circuit at Copper Basin

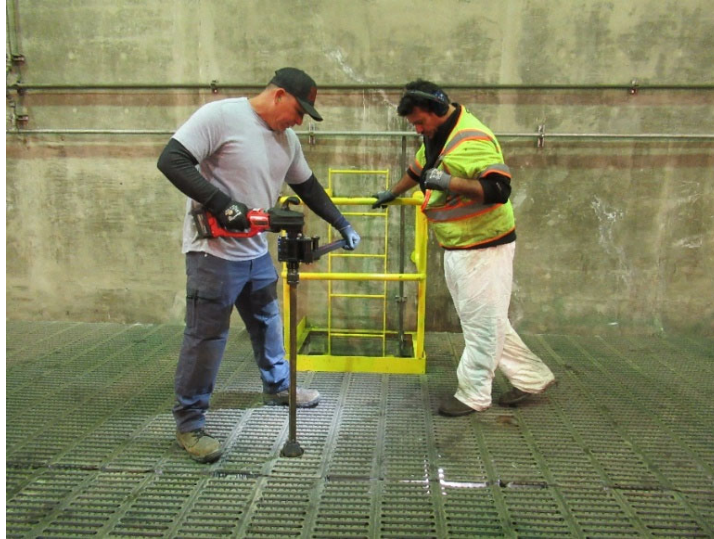
Staff recently completed preventive maintenance at the Venice pressure control structure (PCS). The structure controls the downstream pressure in the Sepulveda Feeder. The PCS has twenty-four 16-inch diameter lines. Each 16-inch line contains three valves; one is a regulating valve and two are manually operated plug valves that are located on each side of the regulating valve.

Staff exercising a plug valve during routine preventive maintenance at Venice PCS

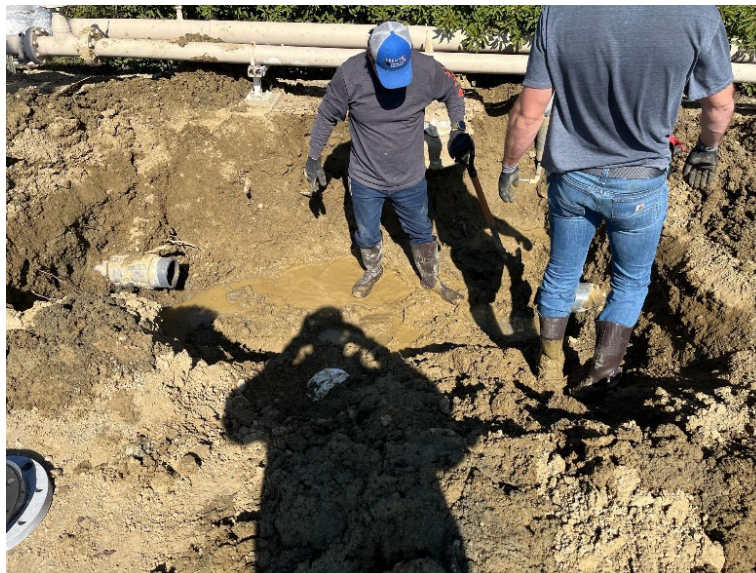
Staff discovered a leak on the 6-inch raw water line at Diemer plant. Staff responded quickly to excavate around the broken line to replace the affected section and return it to service.

Staff repairing a broken water line at the Diemer plant

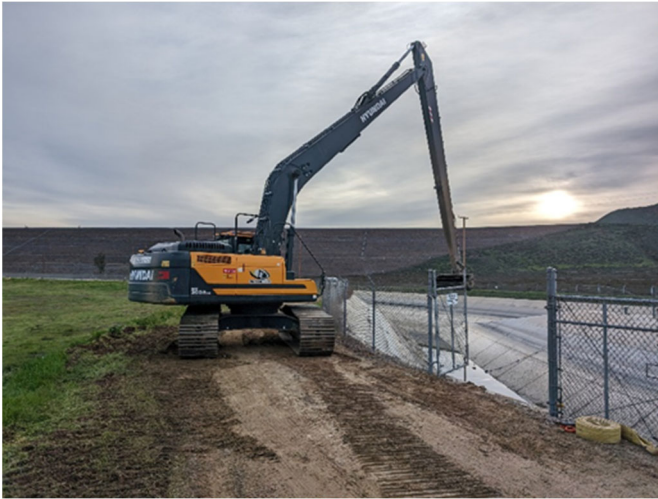
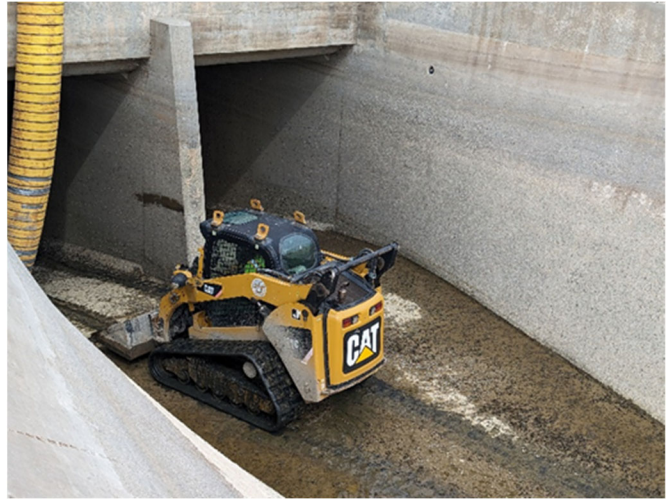
Staff completed annual routine cleaning and maintenance during a scheduled shutdown of the San Diego and Casa Loma Canals between San Jacinto and Lake Skinner. The routine cleaning involves using a long-reach excavator to

remove debris from the sand traps along the canal and skid steers to clean the debris from the siphons. Although heavy equipment is used, staff also needs to enter the siphons to manually scrape and shovel debris. Additionally, during this shutdown, a contractor replaced concrete panels and Metropolitan staff surveyed the canal.

Long-reach excavator (left) and skid steers (right) used to clean and remove debris from the San Diego Canal

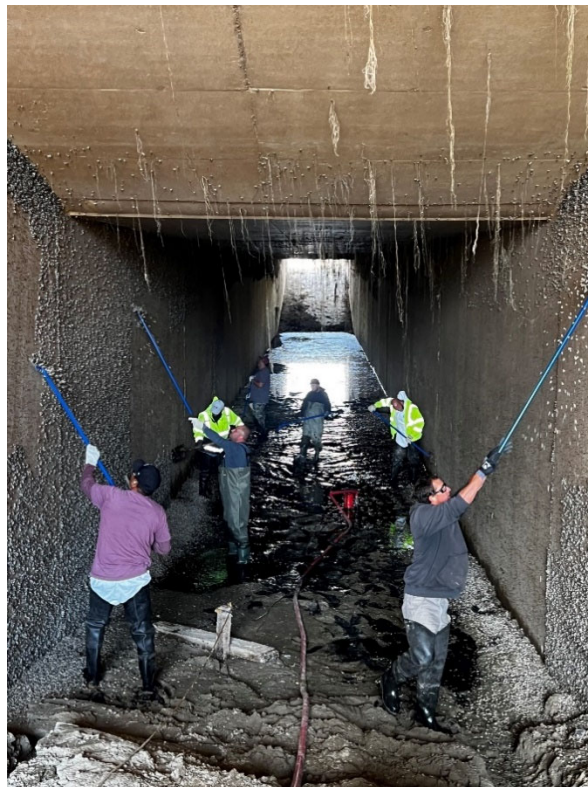
Staff manually scraping debris in the low siphons of the San Diego Canal

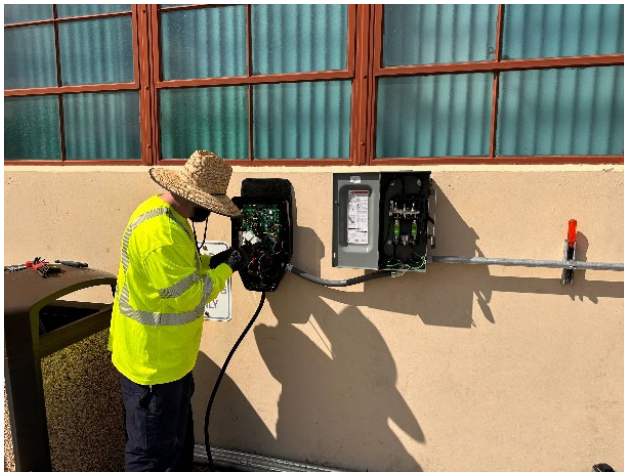
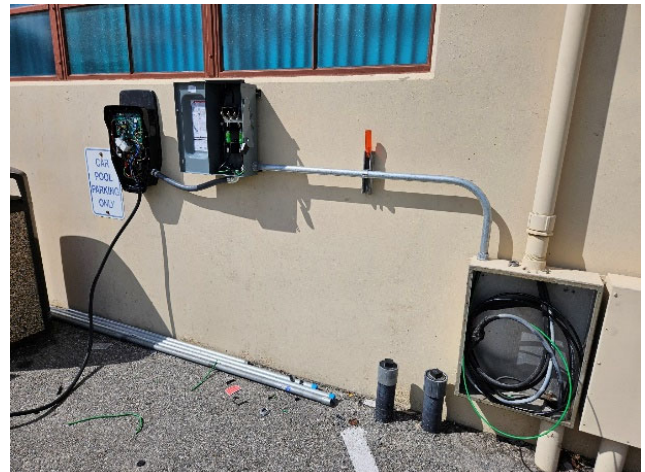
In support of Metropolitan's on-going effort to transition to Zero Emission Vehicles (ZEV), staff is diligently planning for and installing electric vehicle charging equipment at La Verne and other facilities. The Los Angeles Coatings Team will be receiving an electric vehicle and an electric charger will be installed at the Soto Street field facility. In preparation, Metropolitan electricians assessed the current electrical system to ensure adequate electrical capacity while a safe and reliable installation plan was developed. During a scheduled electrical outage at the Soto Street facility, electricians installed supporting equipment for the electric vehicle and charger and made the necessary connections to the power supply system.

Staff terminating conductors (left) and installing electrical equipment (right)

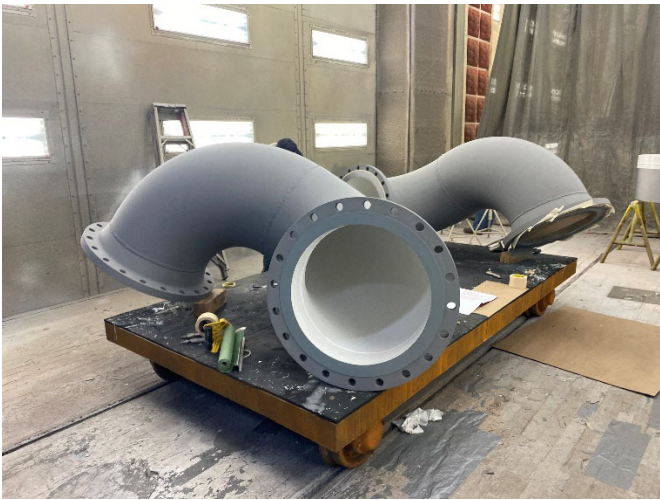
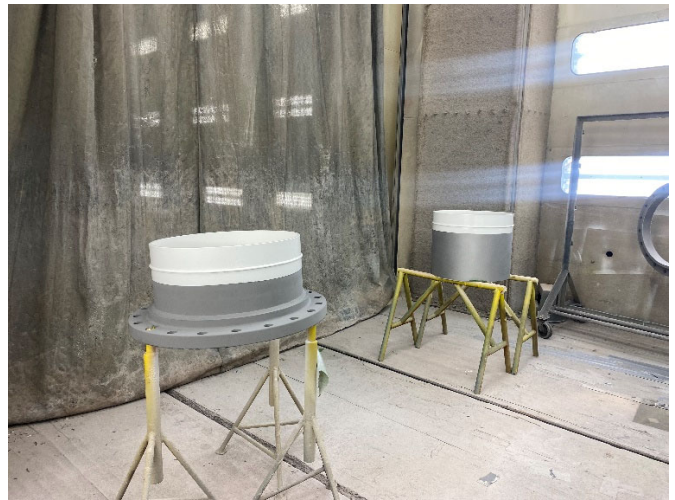
The La Verne Shops received an urgent request to manufacture a 24-inch bypass line within the OC-88 Service Connection Facility on the Allen-McColloch Pipeline (AMP). Staff manufactured the bypass line components in two phases to facilitate installation during a previously scheduled shutdown and eliminate the need to perform an additional shutdown to complete the bypass. With Phase 1 completed in January, Phase 2 components consisted of two 24-inch compound elbows, two spools, two thimbles, and the multiple structural components required to support the Cla-Val pressure control valve and its surrounding platform. Use of this bypass line will help reduce the operating pressure in the AMP while rehabilitation of this prestressed concrete cylinder pipe (PCCP) progresses over the next several months.

La Verne Shops completed 24-inch compound elbows (left) and thimbles (right) for the AMP bypass line at OC-88

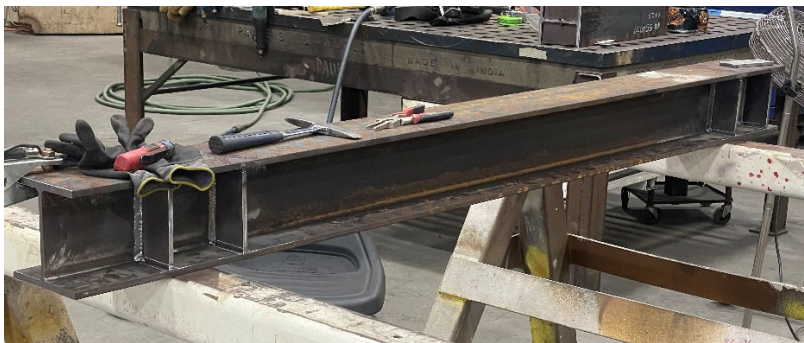
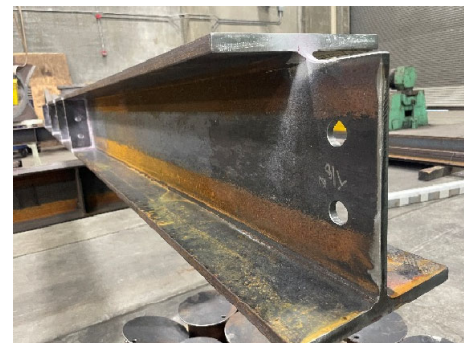
Structural cross-member being fabricated (left) and completed main beam (right) for the AMP bypass line at OC-88
