Allen McColloch Pipeline - Inspection Update Action Plan

January 8, 2024

Allen McColloch Pipeline (AMP) Inspection Update Action Plan

Summarize condition assessment of AMP Prestressed Concrete Cylinder Pipeline (PCCP) by including results of recent inspection & preliminary risk analysis. Review mitigation measures & present pipeline rehabilitation plan.

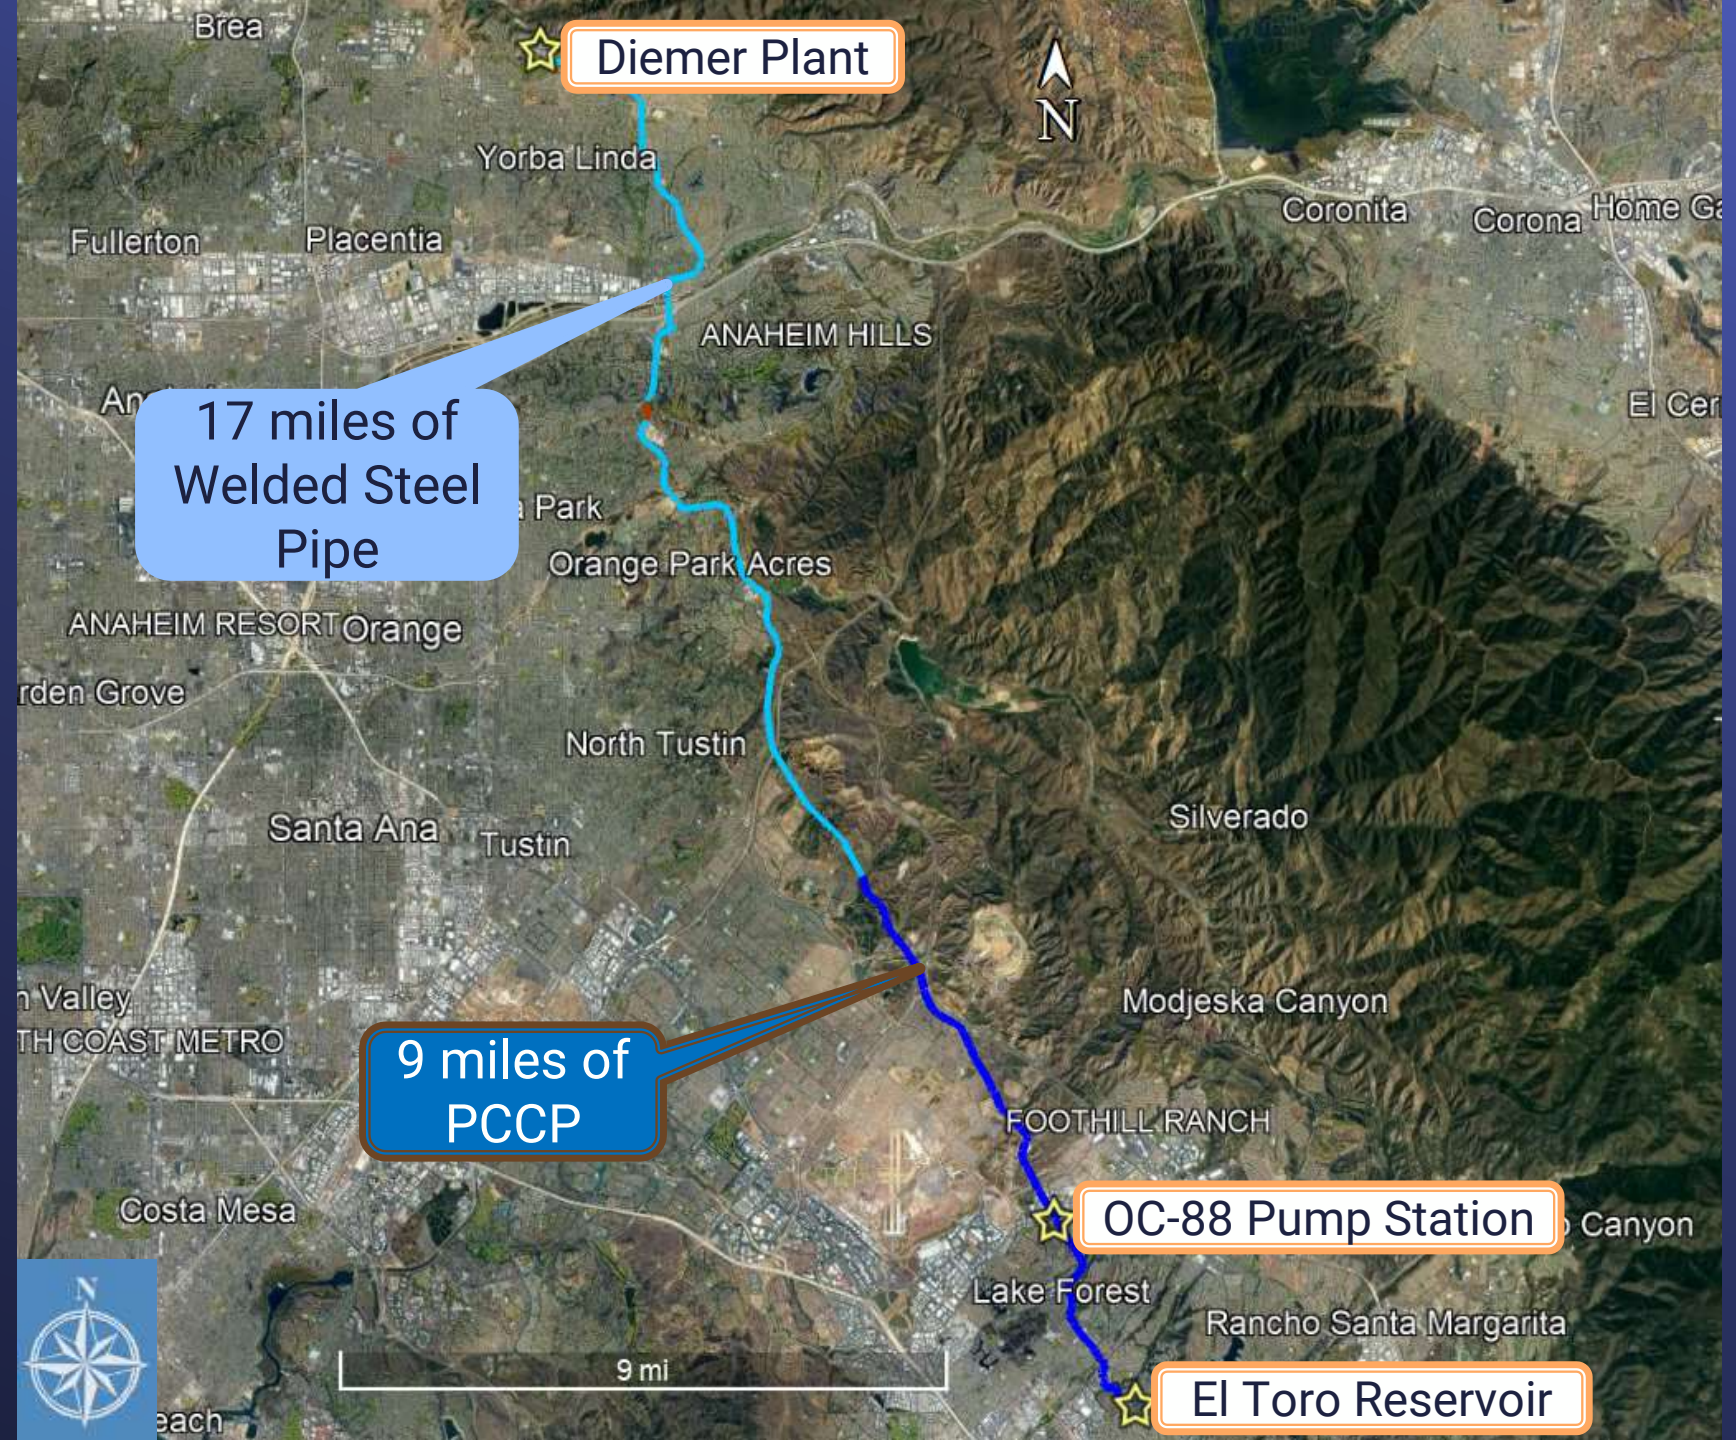
- Completed: 1980
- Acquired: 1995
- Length: 26 miles
 - Steel: 17 miles
 - PCCP: 9 miles
- PCCP diameters from 78" to 54"
