Engineering & Operations Committee

Water System Operations Manager's Report

Upper Feeder Leak April 13, 2022

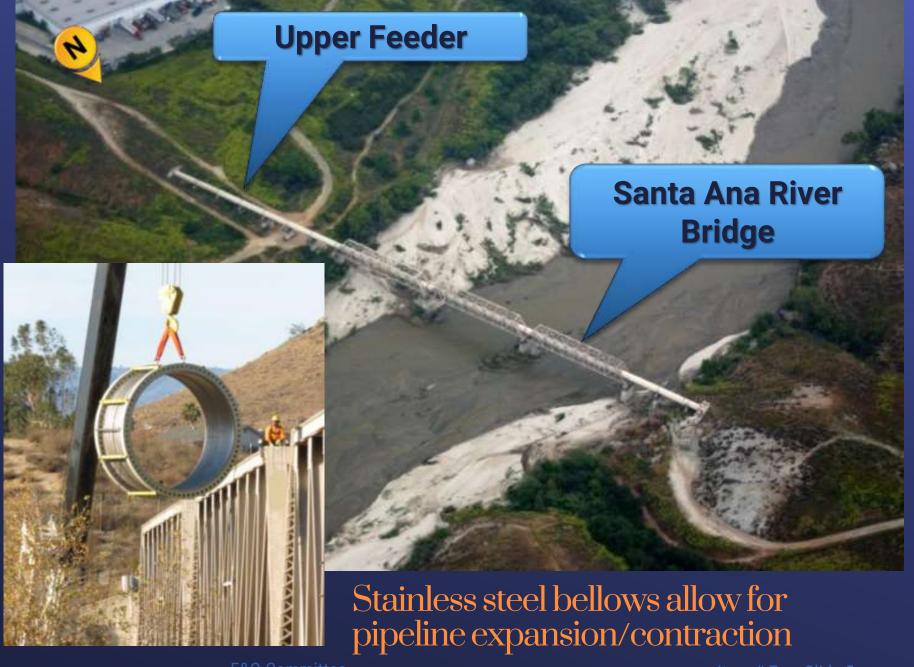
Upper Feeder - Santa Ana River Bridge

- l0l0'Longll6"Diameter
- 750 cfs max flow

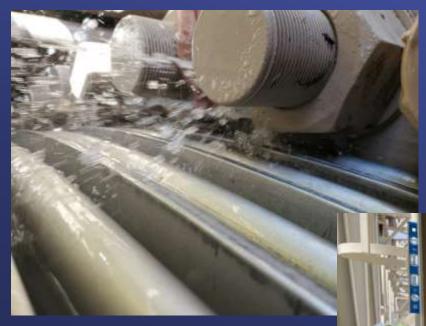
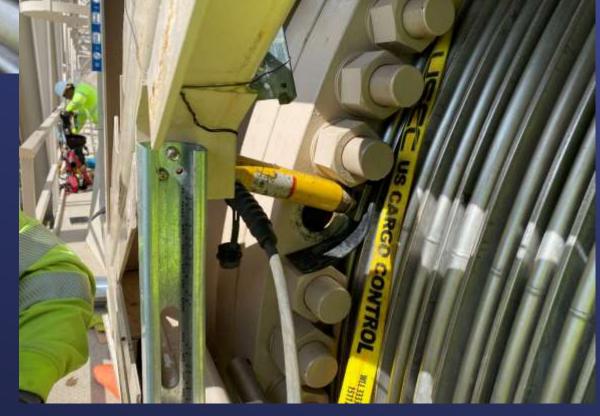
Upper Feeder
- Santa Ana
River Bridge

Liquid penetrant testing conducted

• No additional cracks observed

Leak on bellows expansion joint

Immediate temporary repair using rubber seal and jacking system
